Net Zero Energy Retrofit of a Brooklyn Townhouse

David White
Right Environments

Jason Taylor
Byggmeister

McGowan Southworth
Brooklyn Power

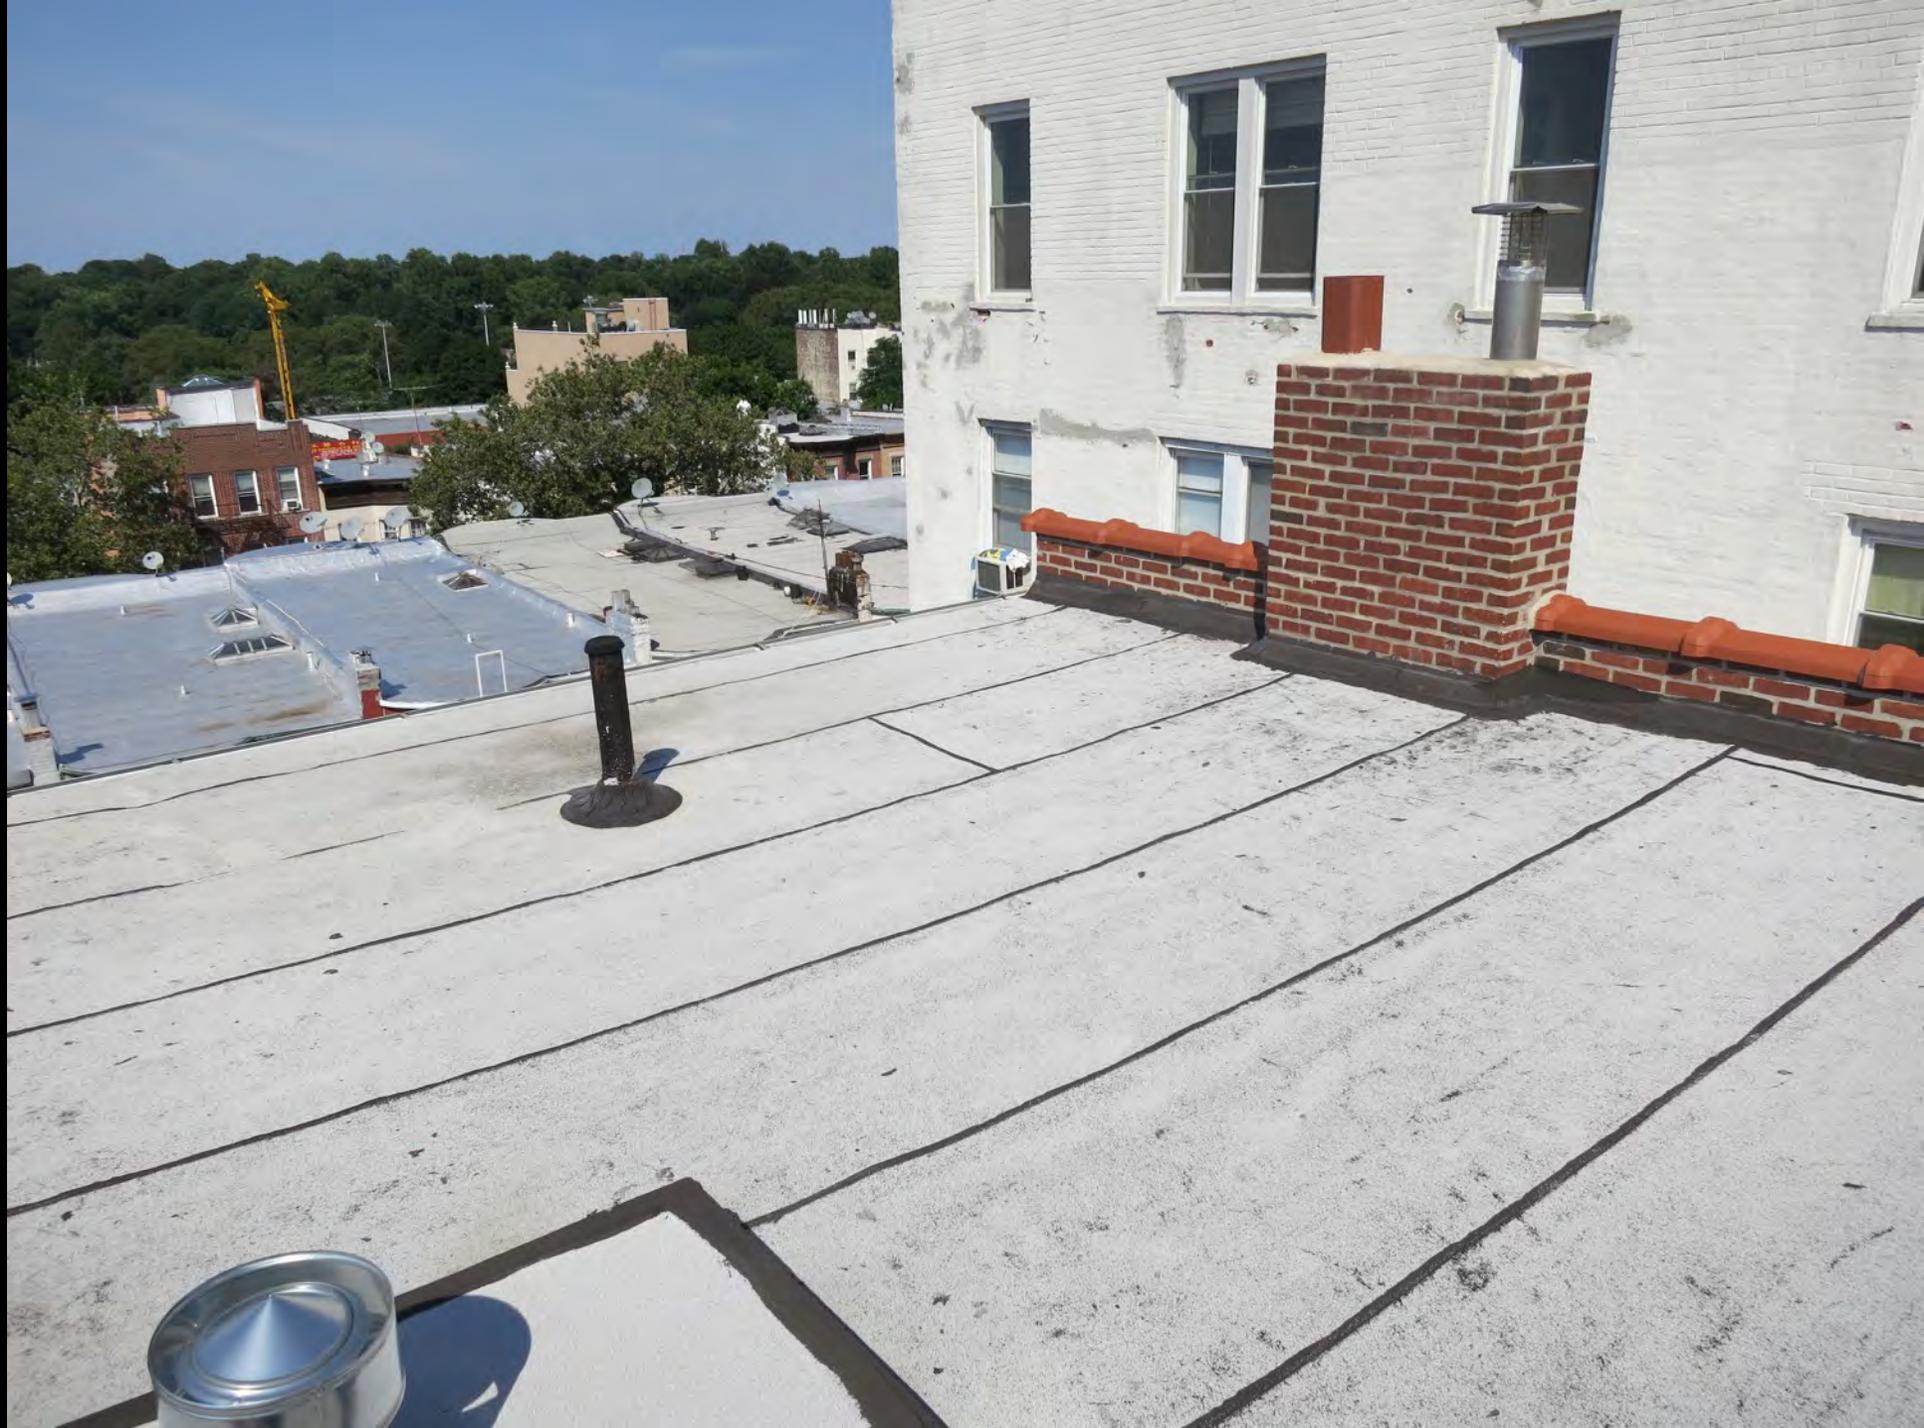
- Walls – 2- and 3-wythe brick with interior plaster over wood lath over stud frame. Exterior stucco in satisfactory condition.
- Roof – 2" loose mineral wool between ceiling framing. Fairly new roof with some pocketing.

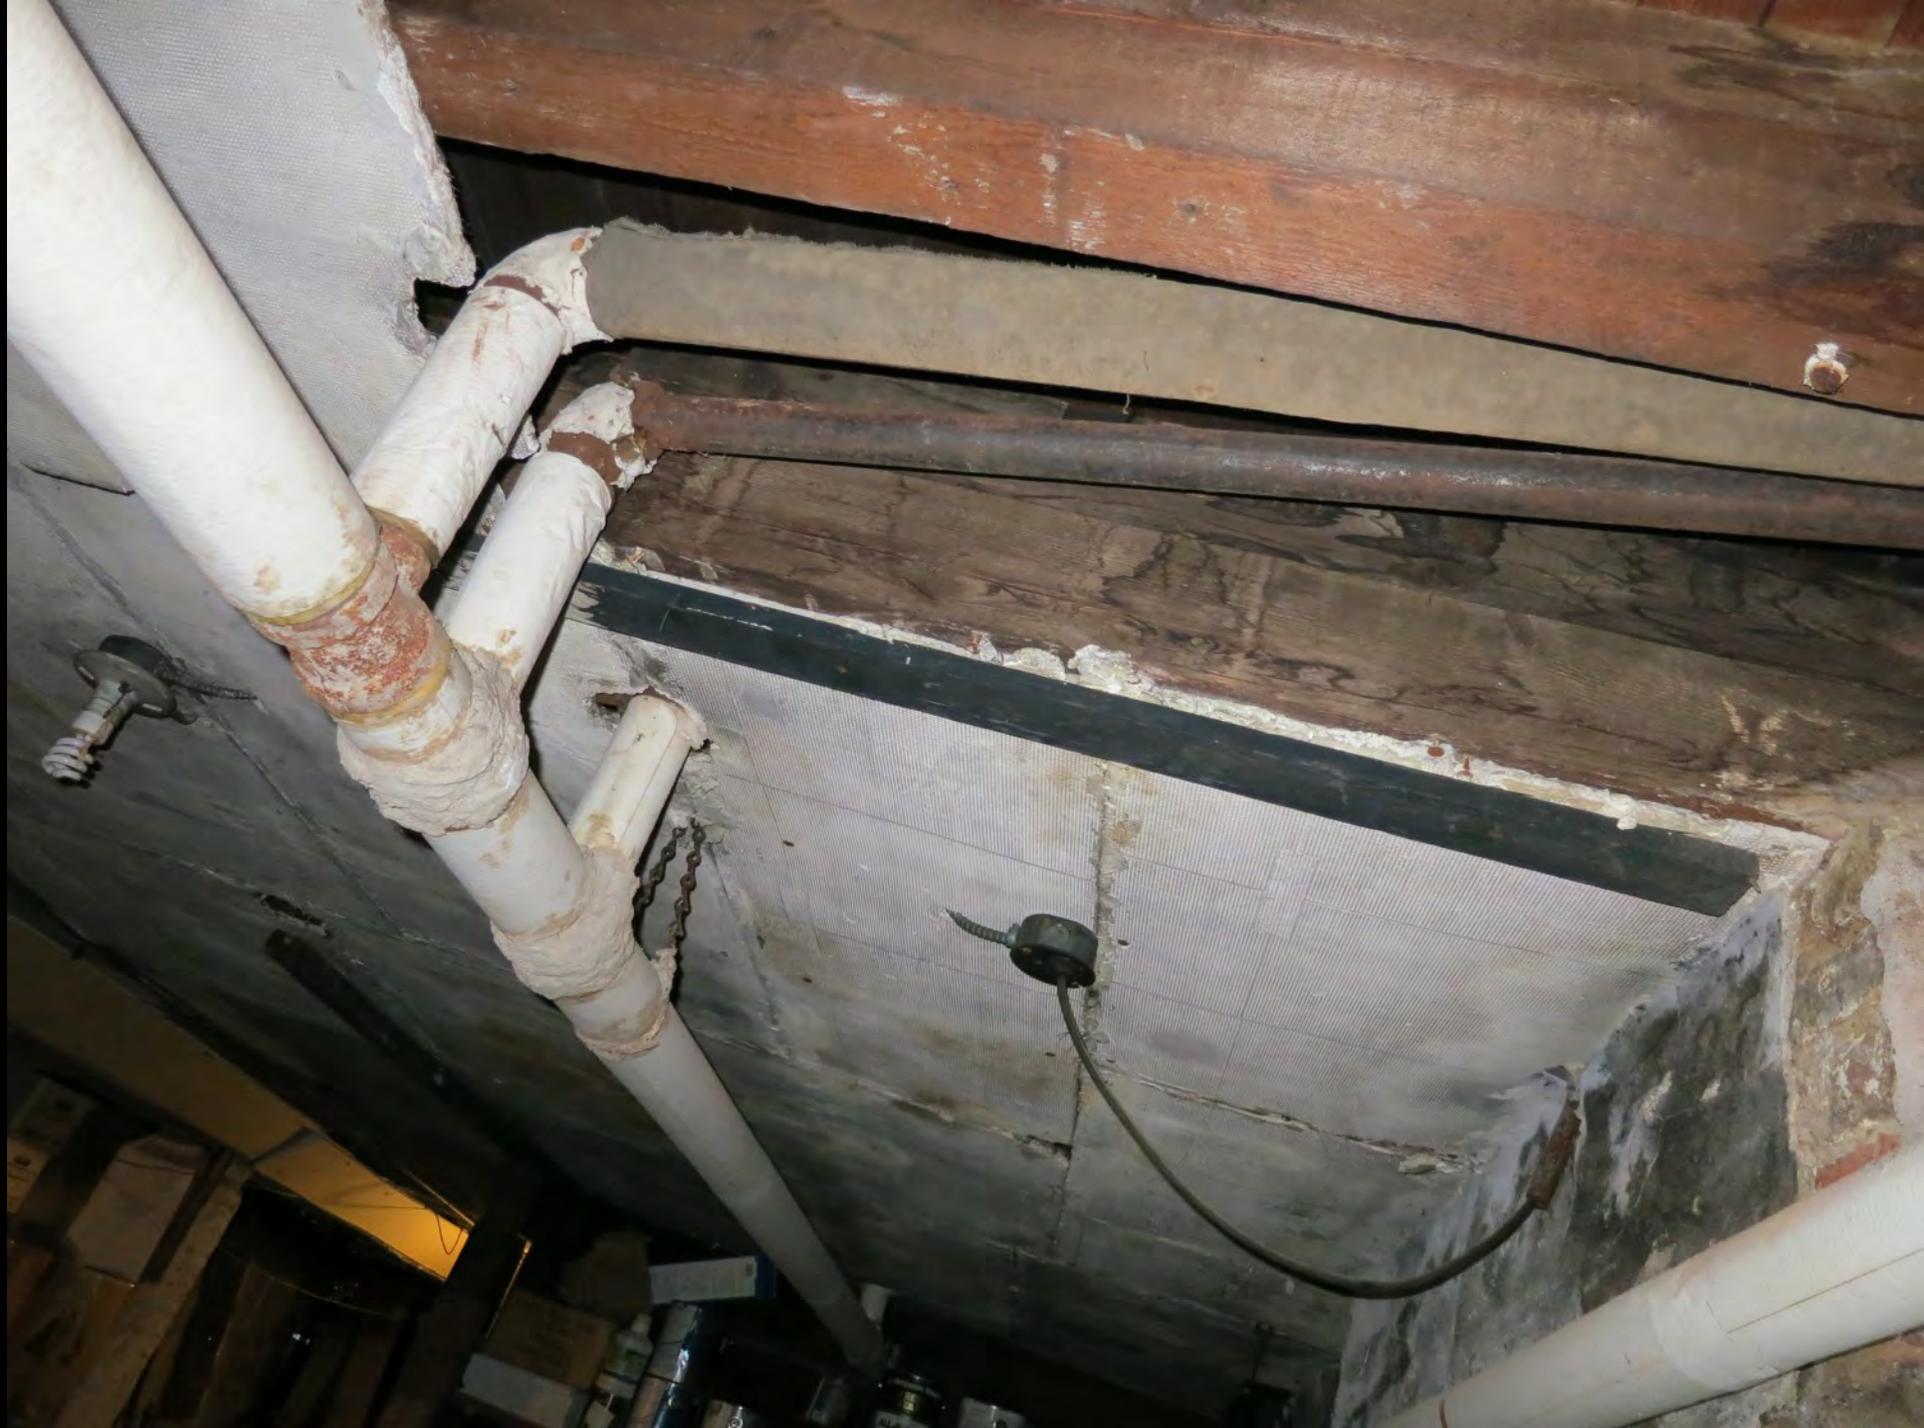
- Walls – 2- and 3-wythe brick with interior plaster over wood lath over stud frame. Exterior stucco in satisfactory condition.
- Roof – 2" loose mineral wool between ceiling framing. Fairly new roof with some pocketing.
- Floor – uninsulated frame floor to basement; much of basement ceiling removed for service runs

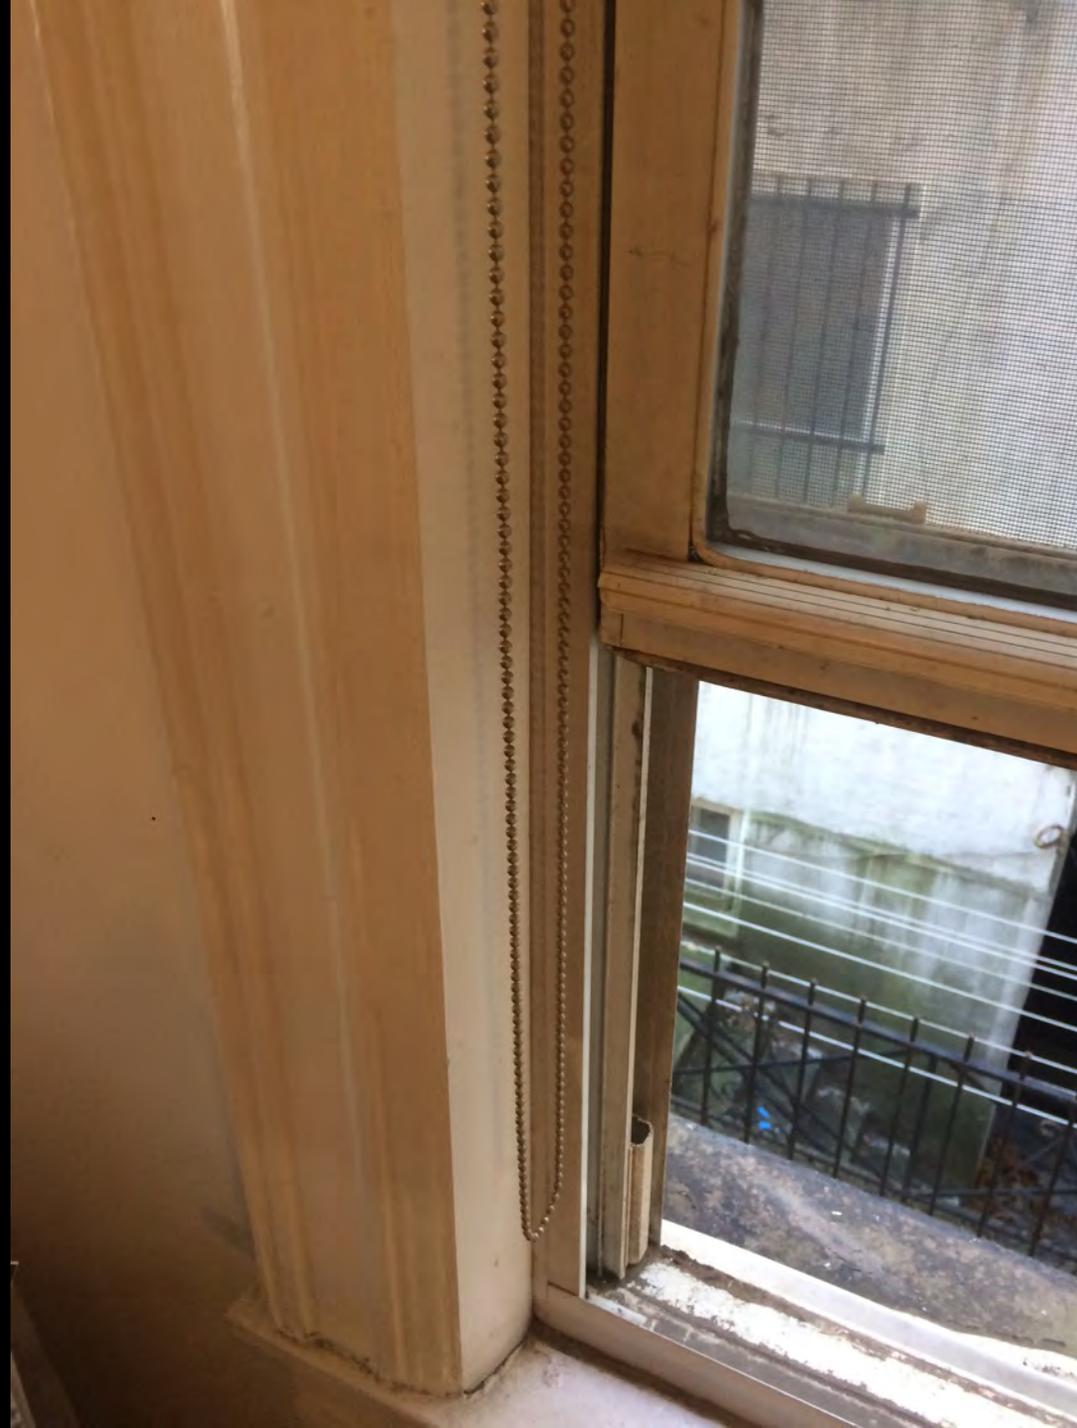
- Broken springs
- Inability to close/open
- Sashes prone to fall in to interior
- Convective bypass in weight pockets

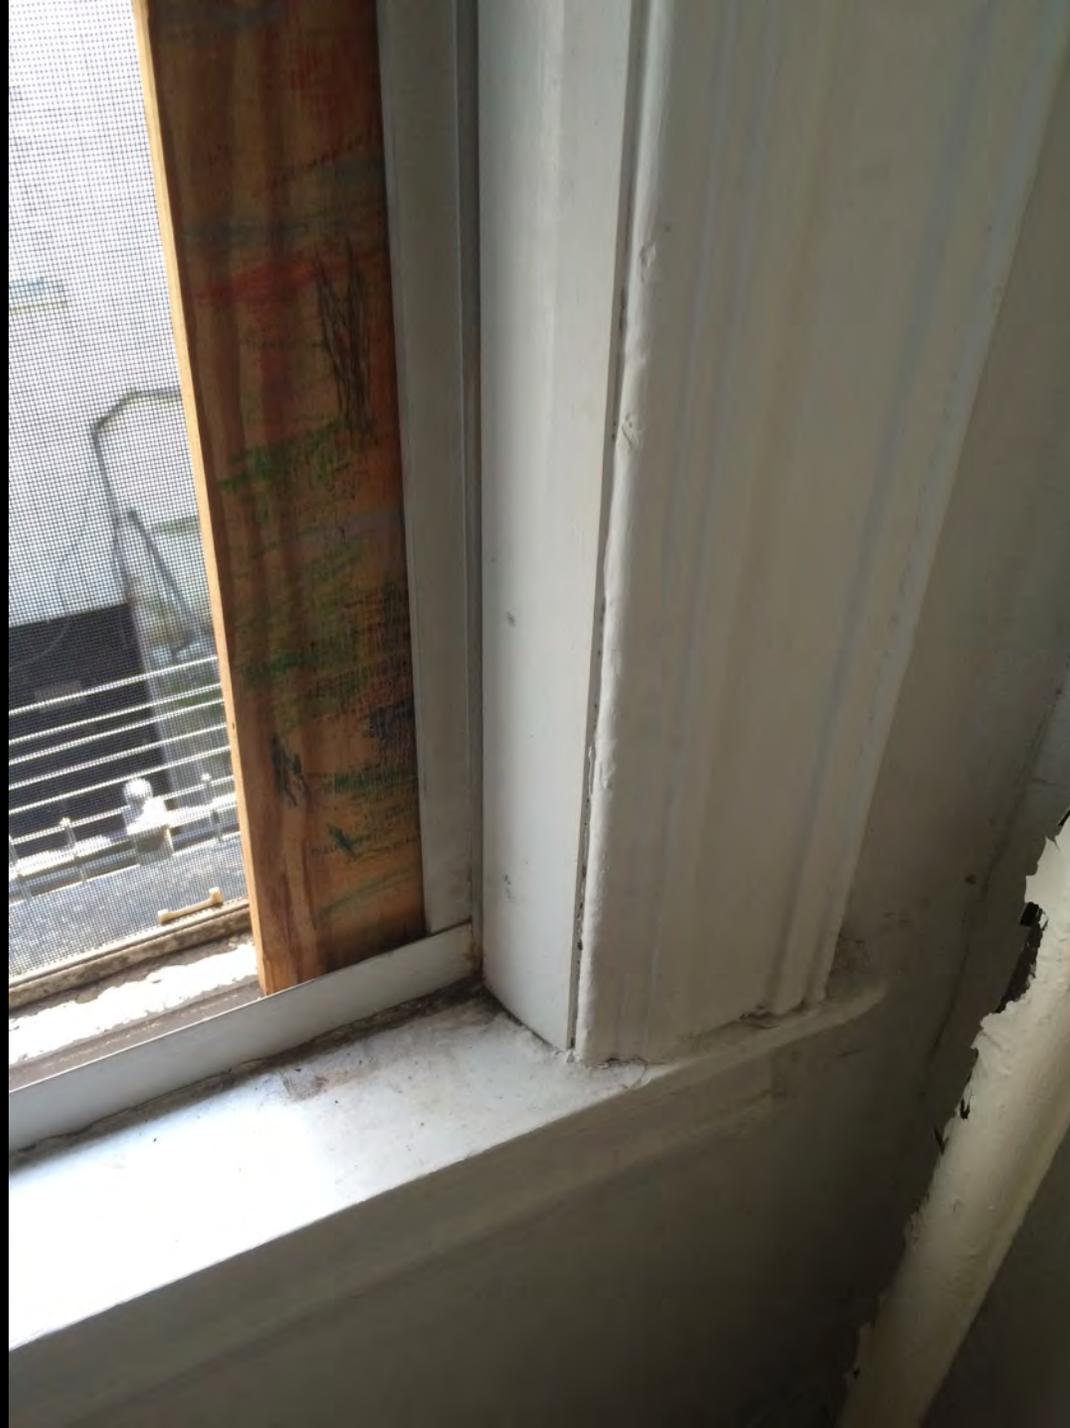
- Broken springs
- Inability to close/open
- Sashes prone to fall in to interior
- Convective bypass in weight pockets

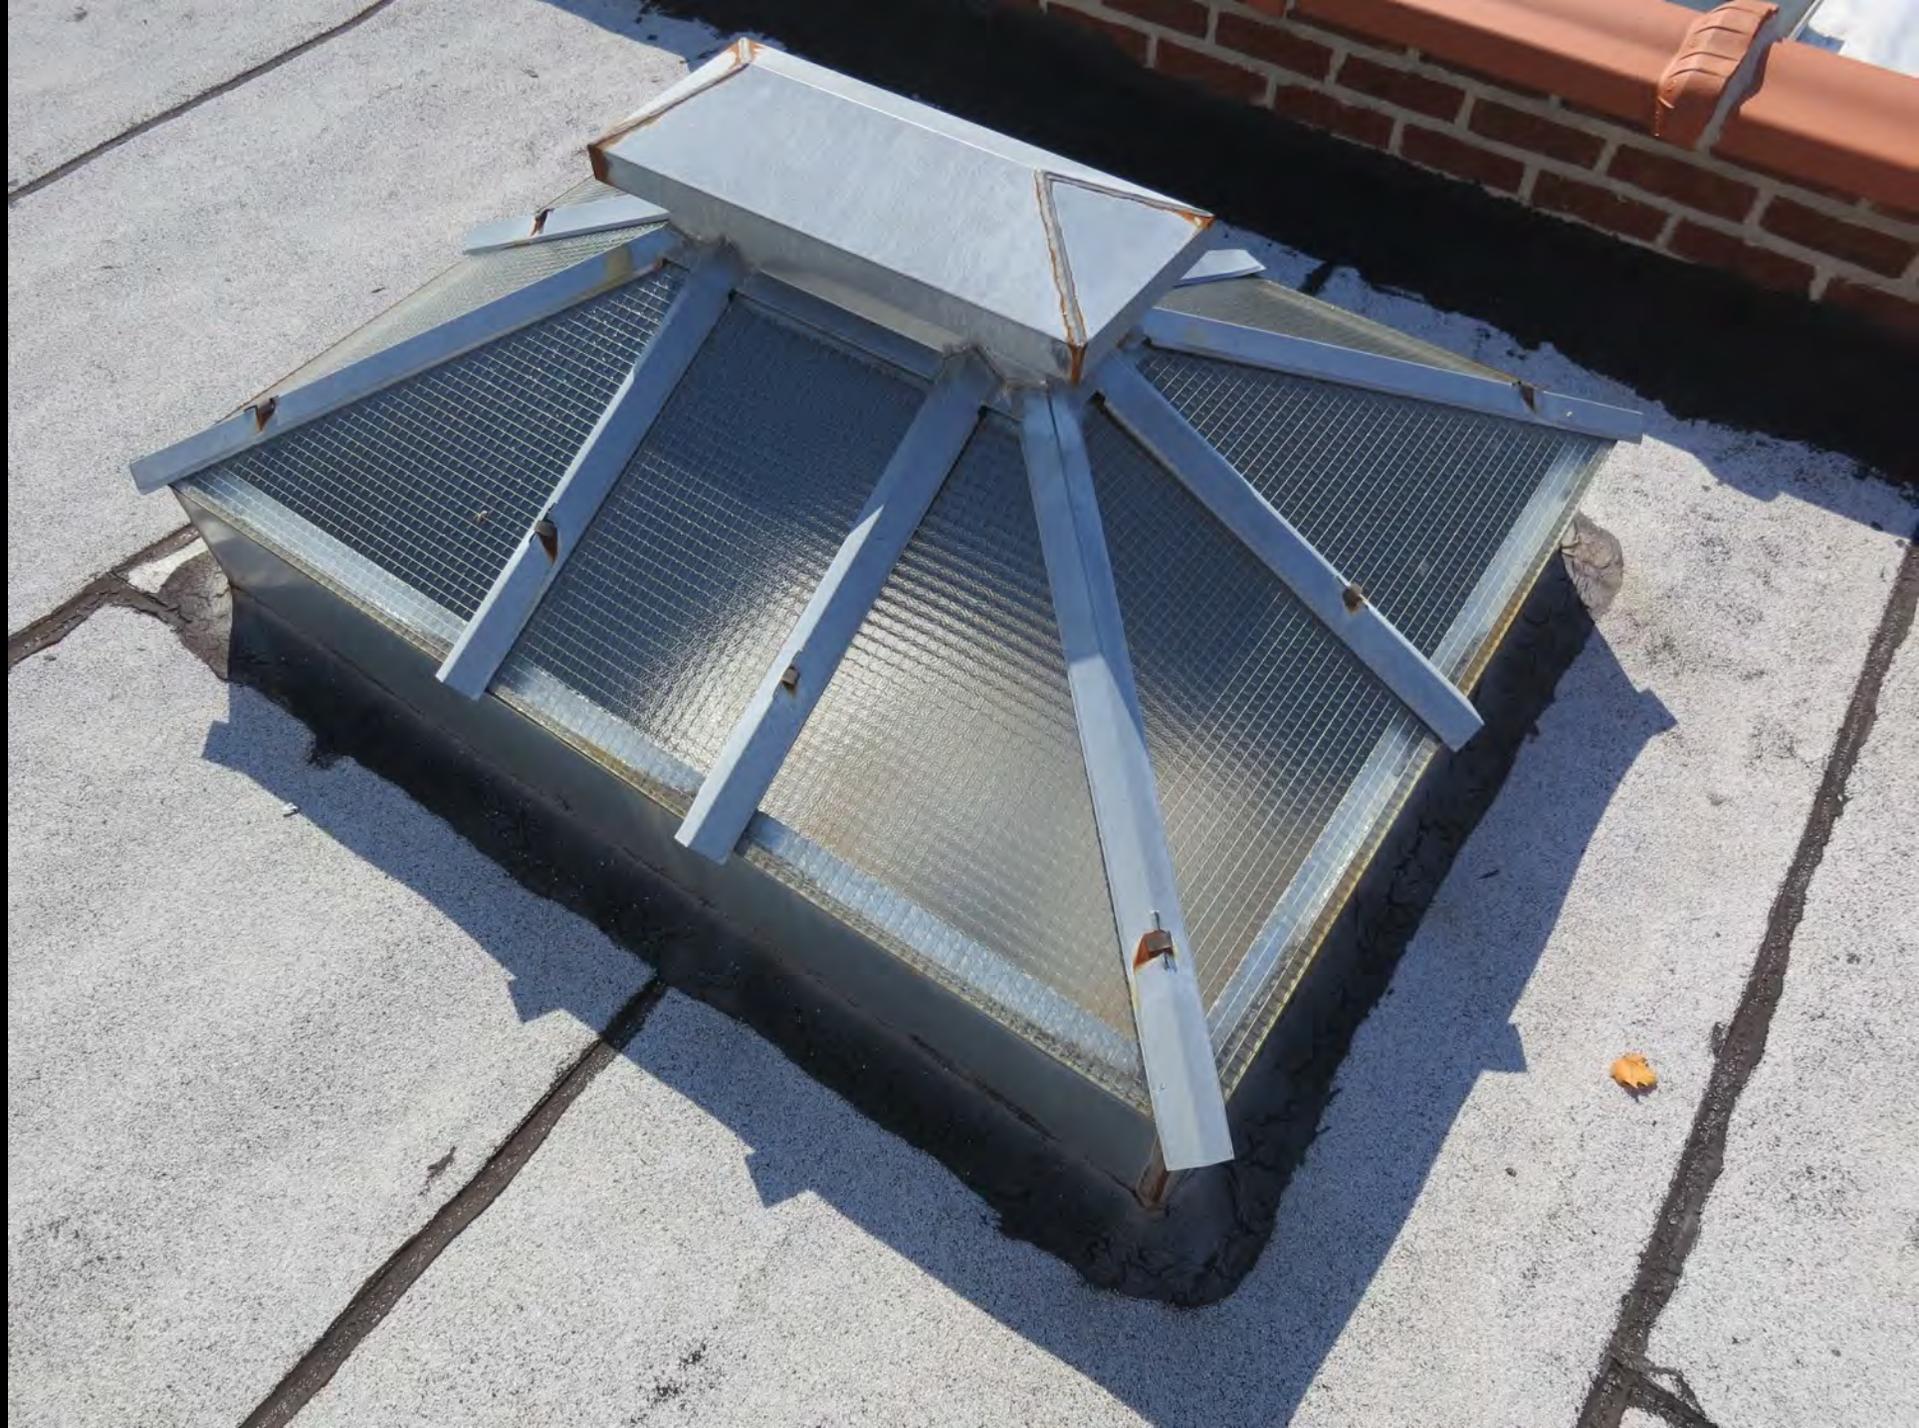
- Typical intentionally vented construction
- Thick debris collecting on stained glass below

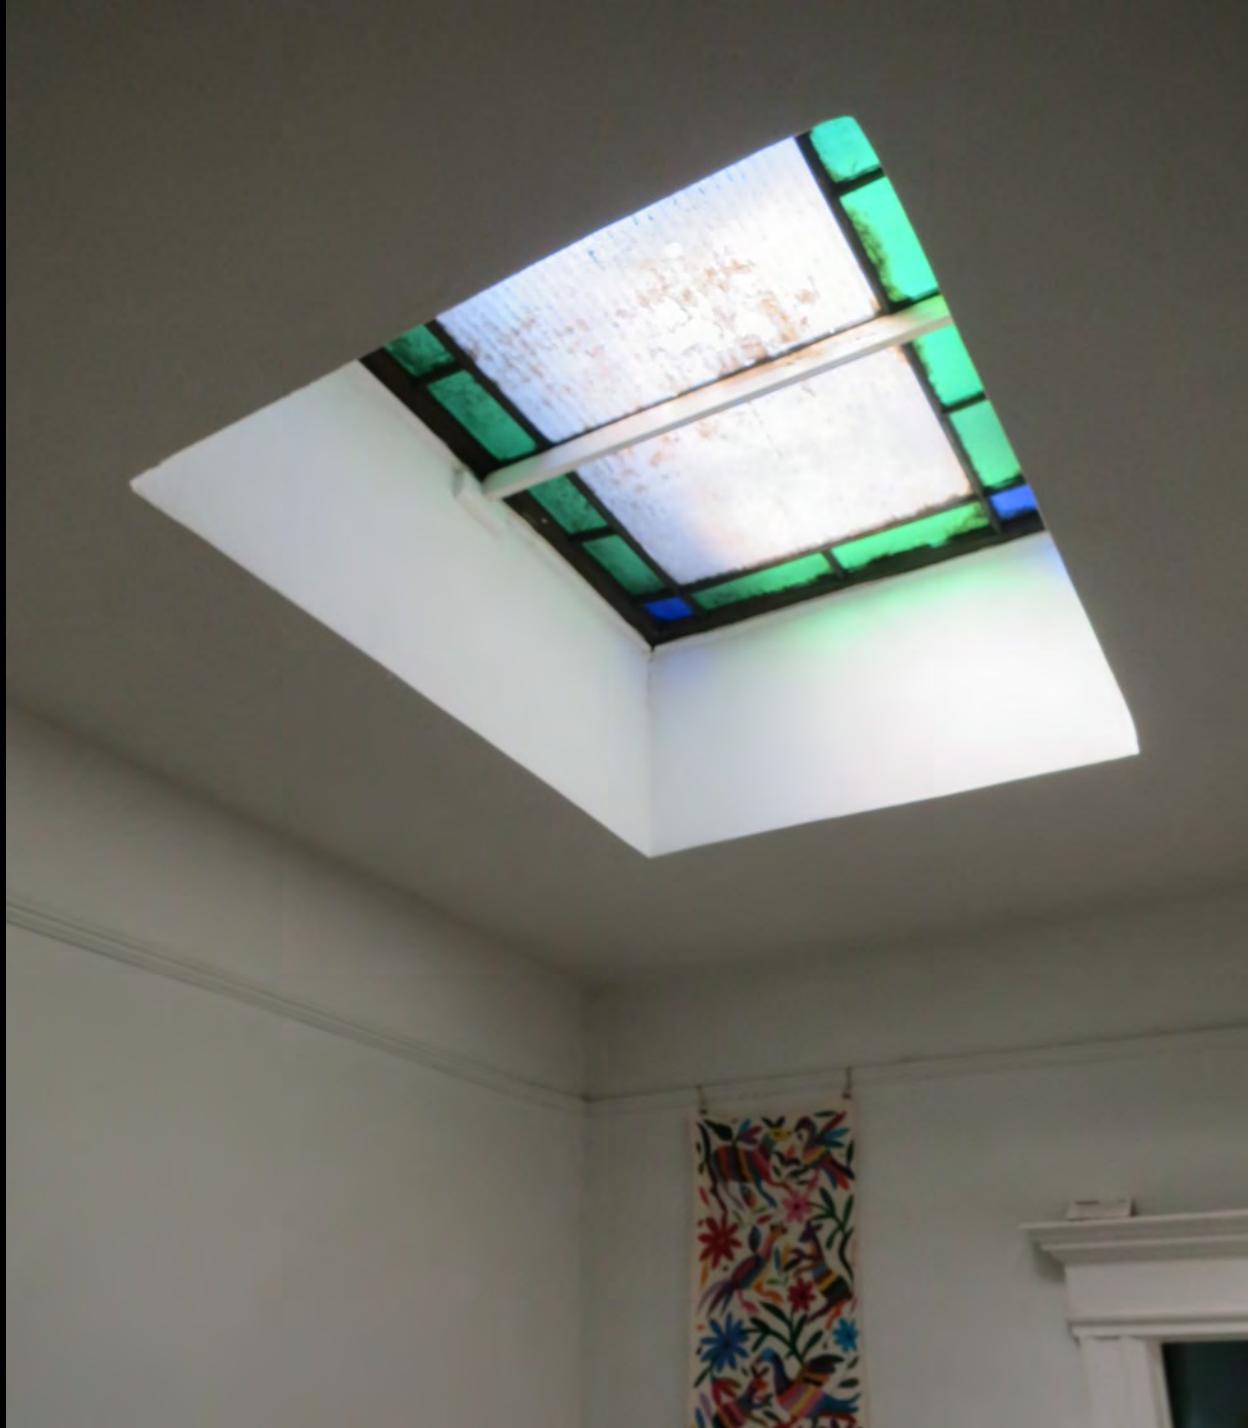
- Typical intentionally vented construction
- Thick debris collecting on stained glass below

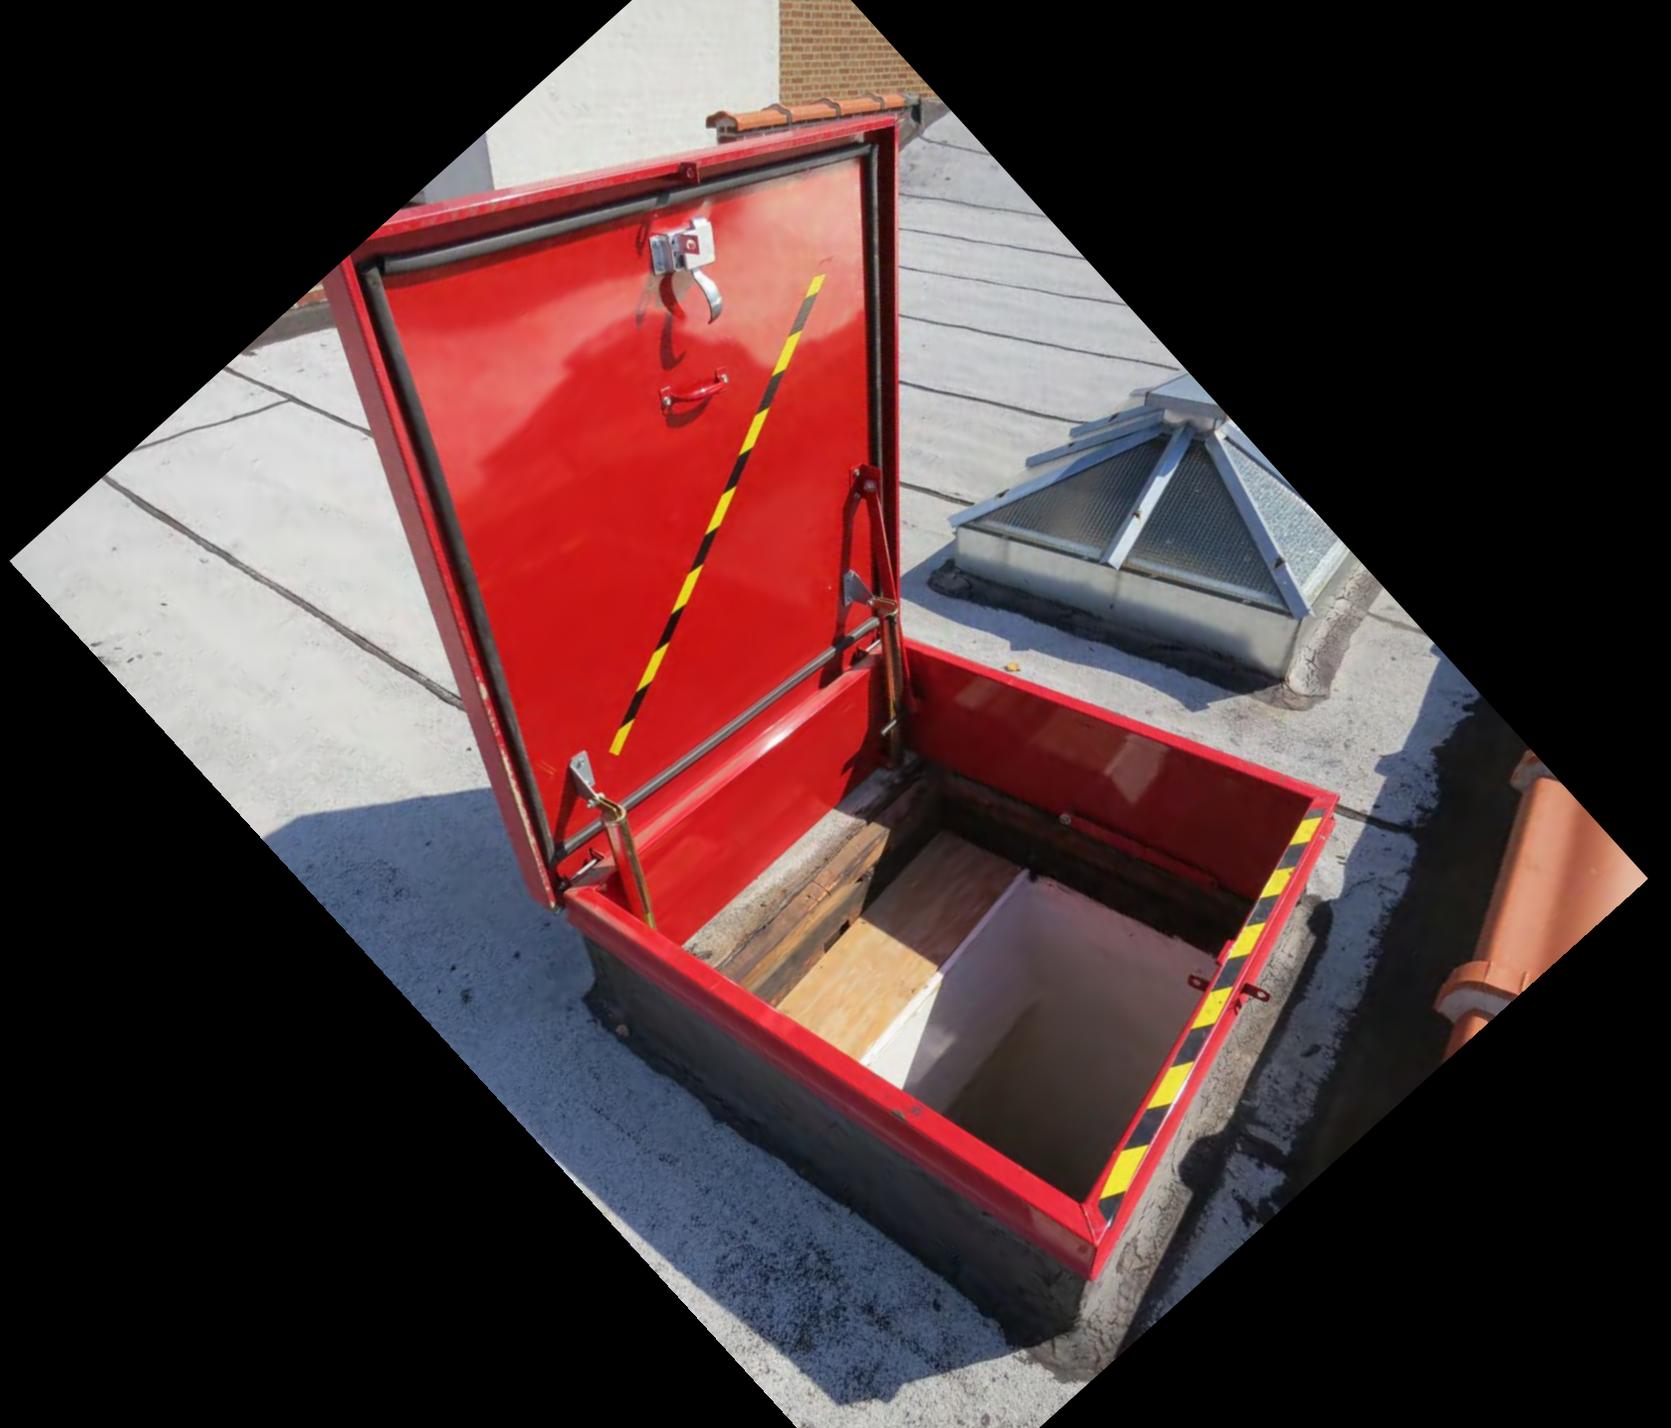
- Typical type
- Insulated but heavily thermally bridged

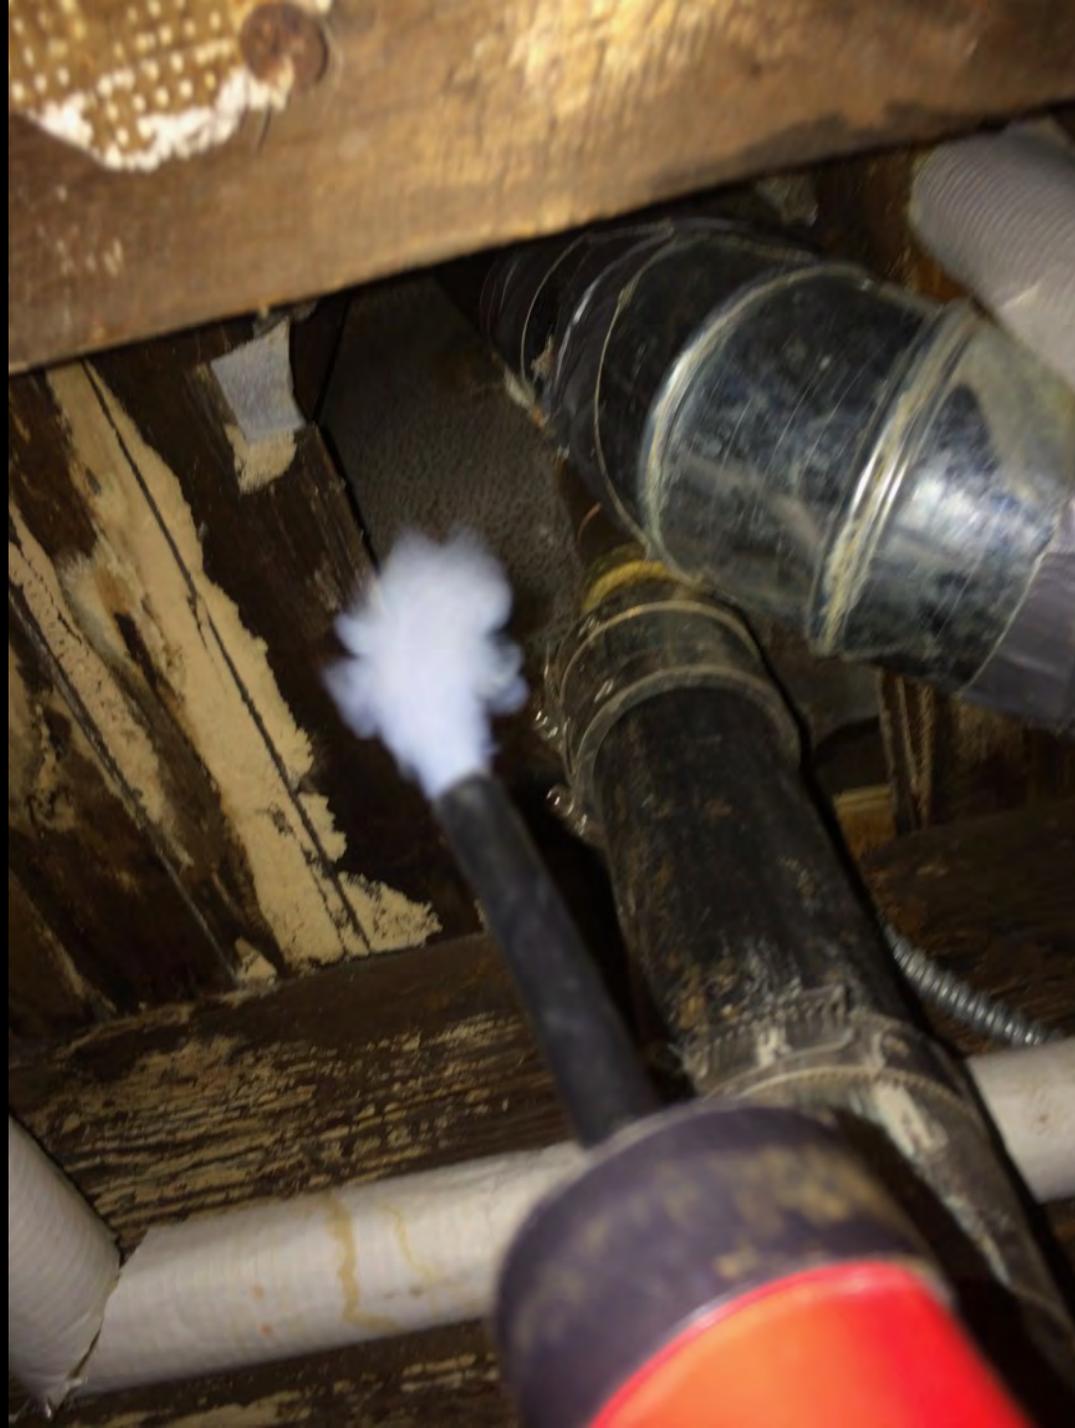
- Blower door and smoke puffer for diagnosis
- Biggest leaks found in attic and cellar (outdoors to cellar and cellar to house).
- Service shaft open to cellar shown at right

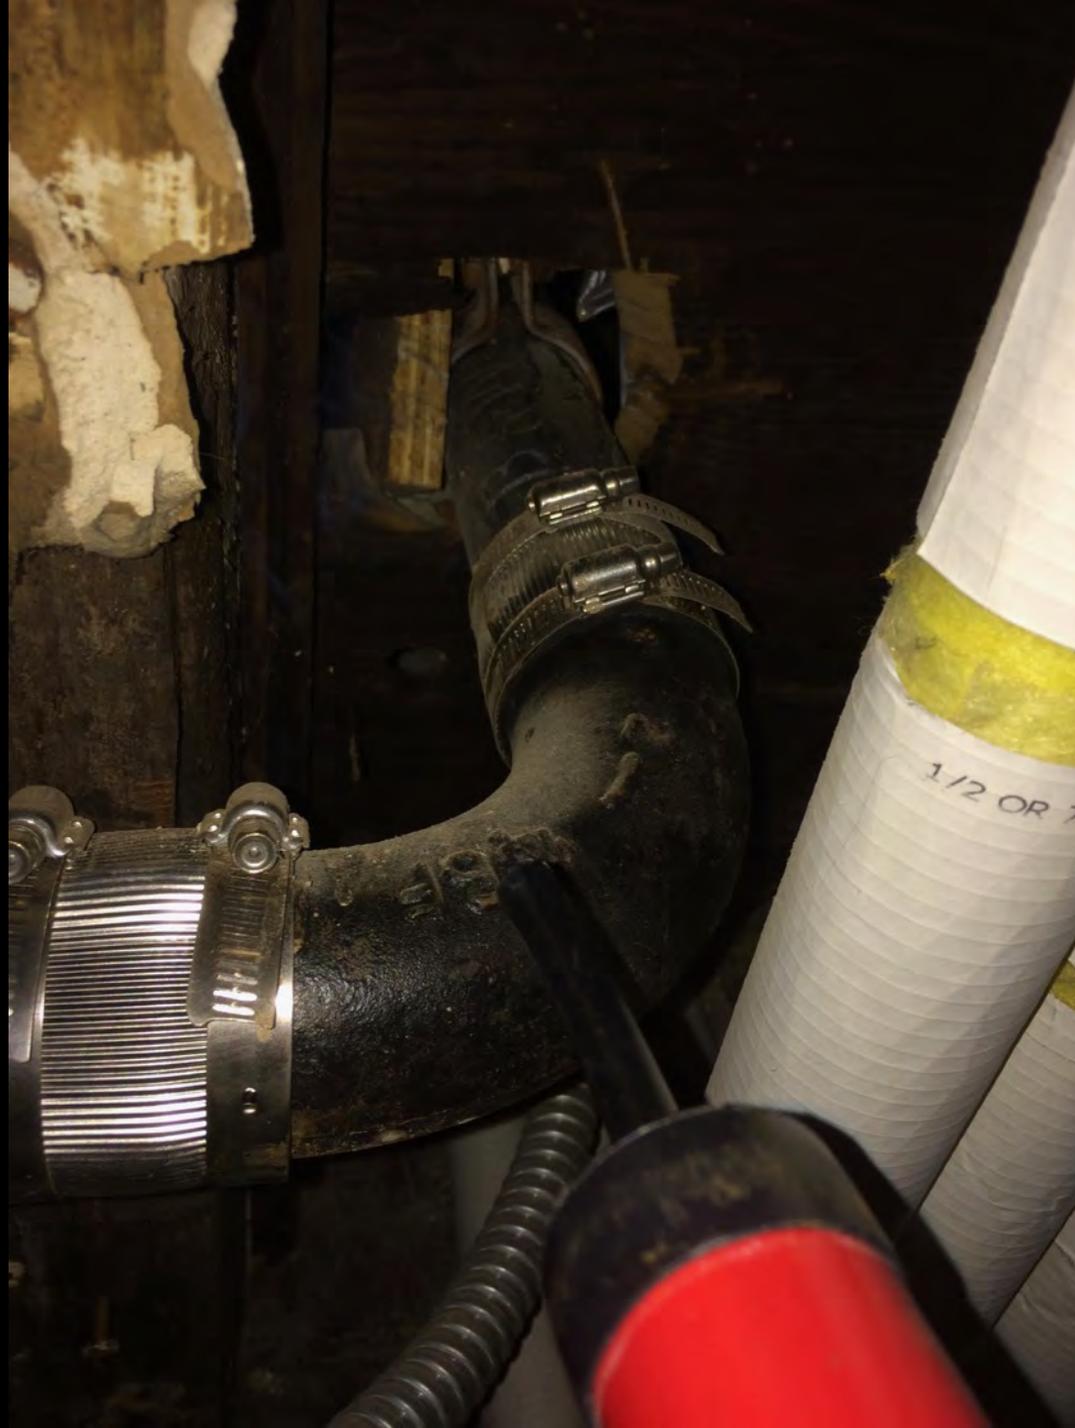
- Biggest leaks in attic and cellar
- Service shafts open to cellar

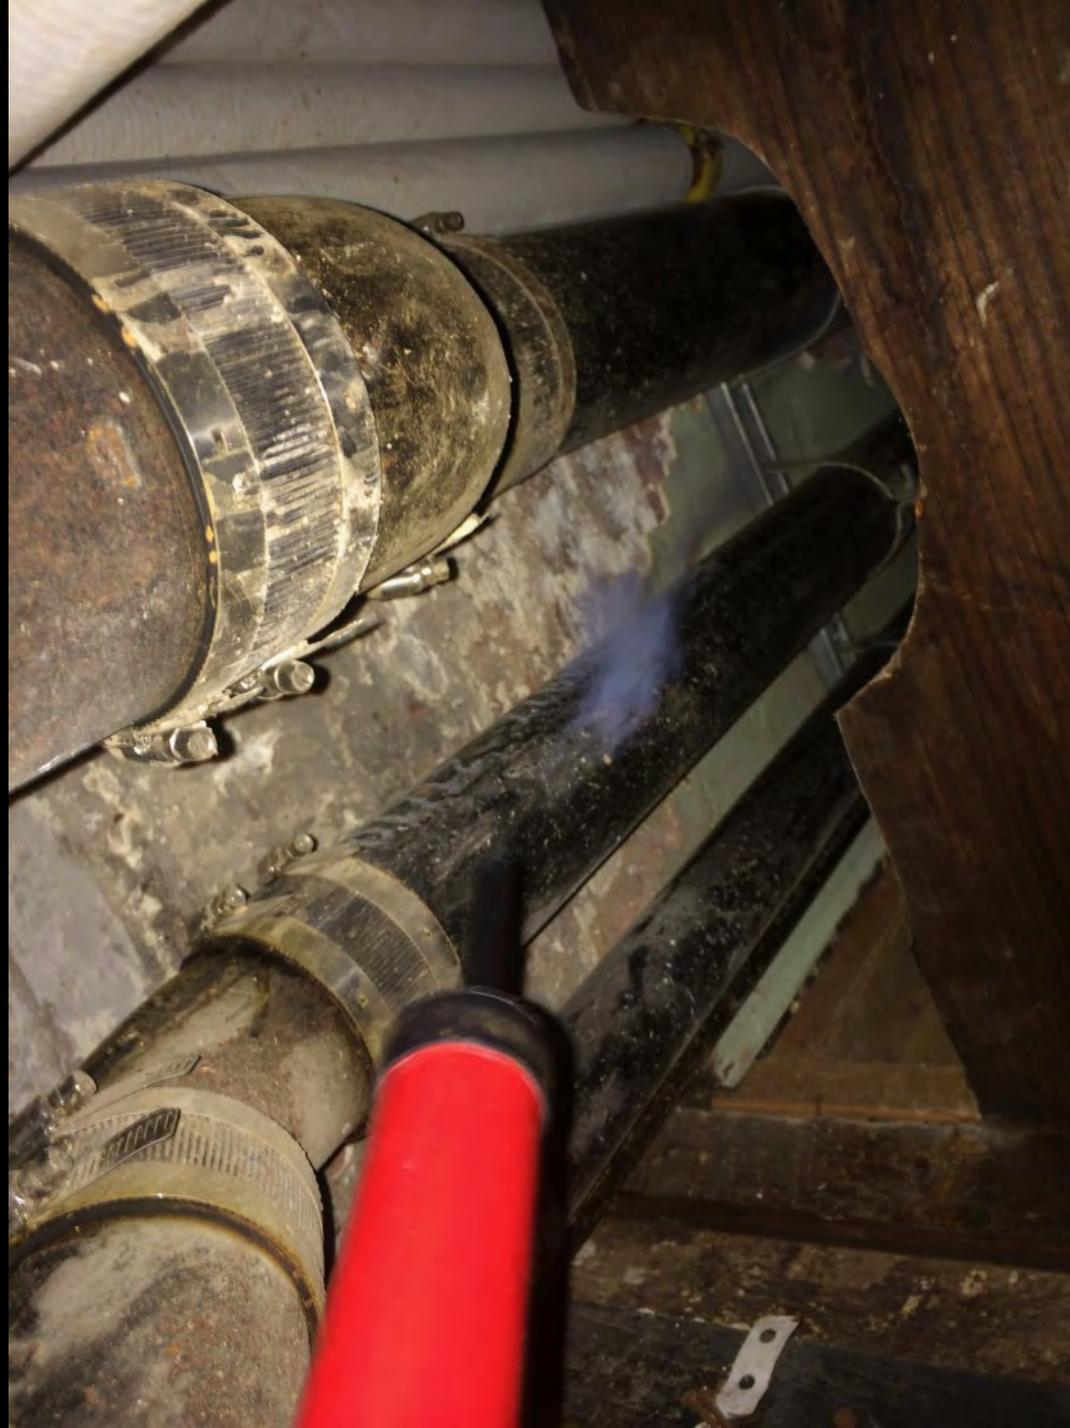
- Biggest leaks in attic and cellar
- Service shafts open to cellar

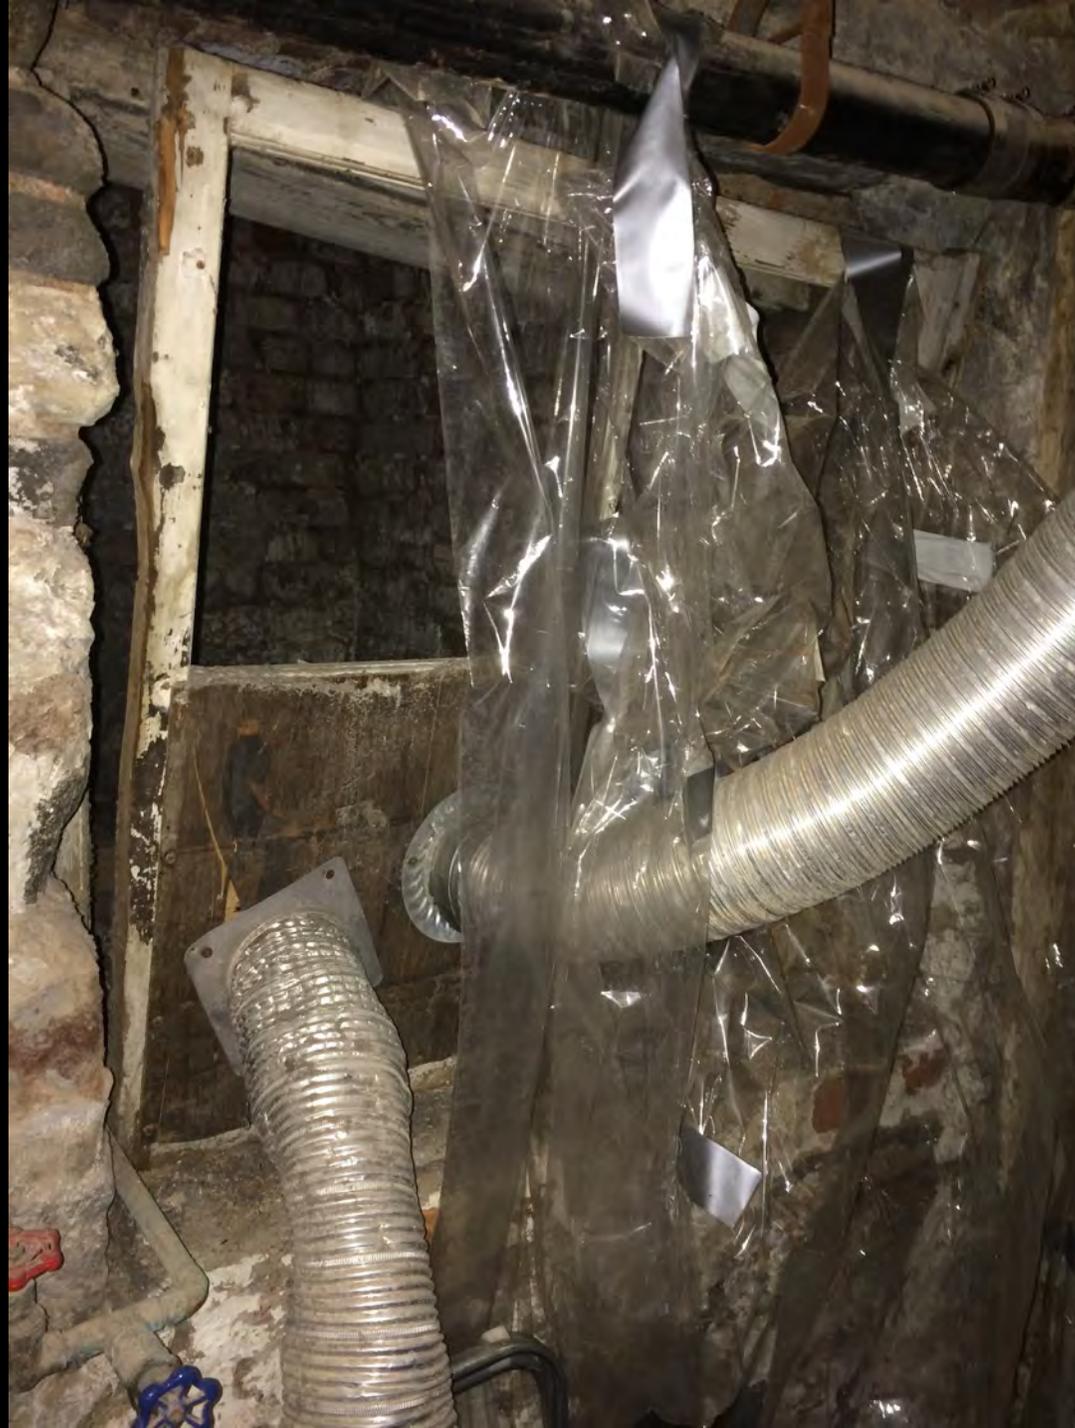
- Biggest leaks in attic and cellar
- Service shafts open to cellar
- Curtain to seal dryer exhaust from cellar
