Net Zero Energy Retrofit of a Brooklyn Townhouse

David White
Right Environments

Jason Taylor
Byggmeister

McGowan Southworth
Brooklyn Power

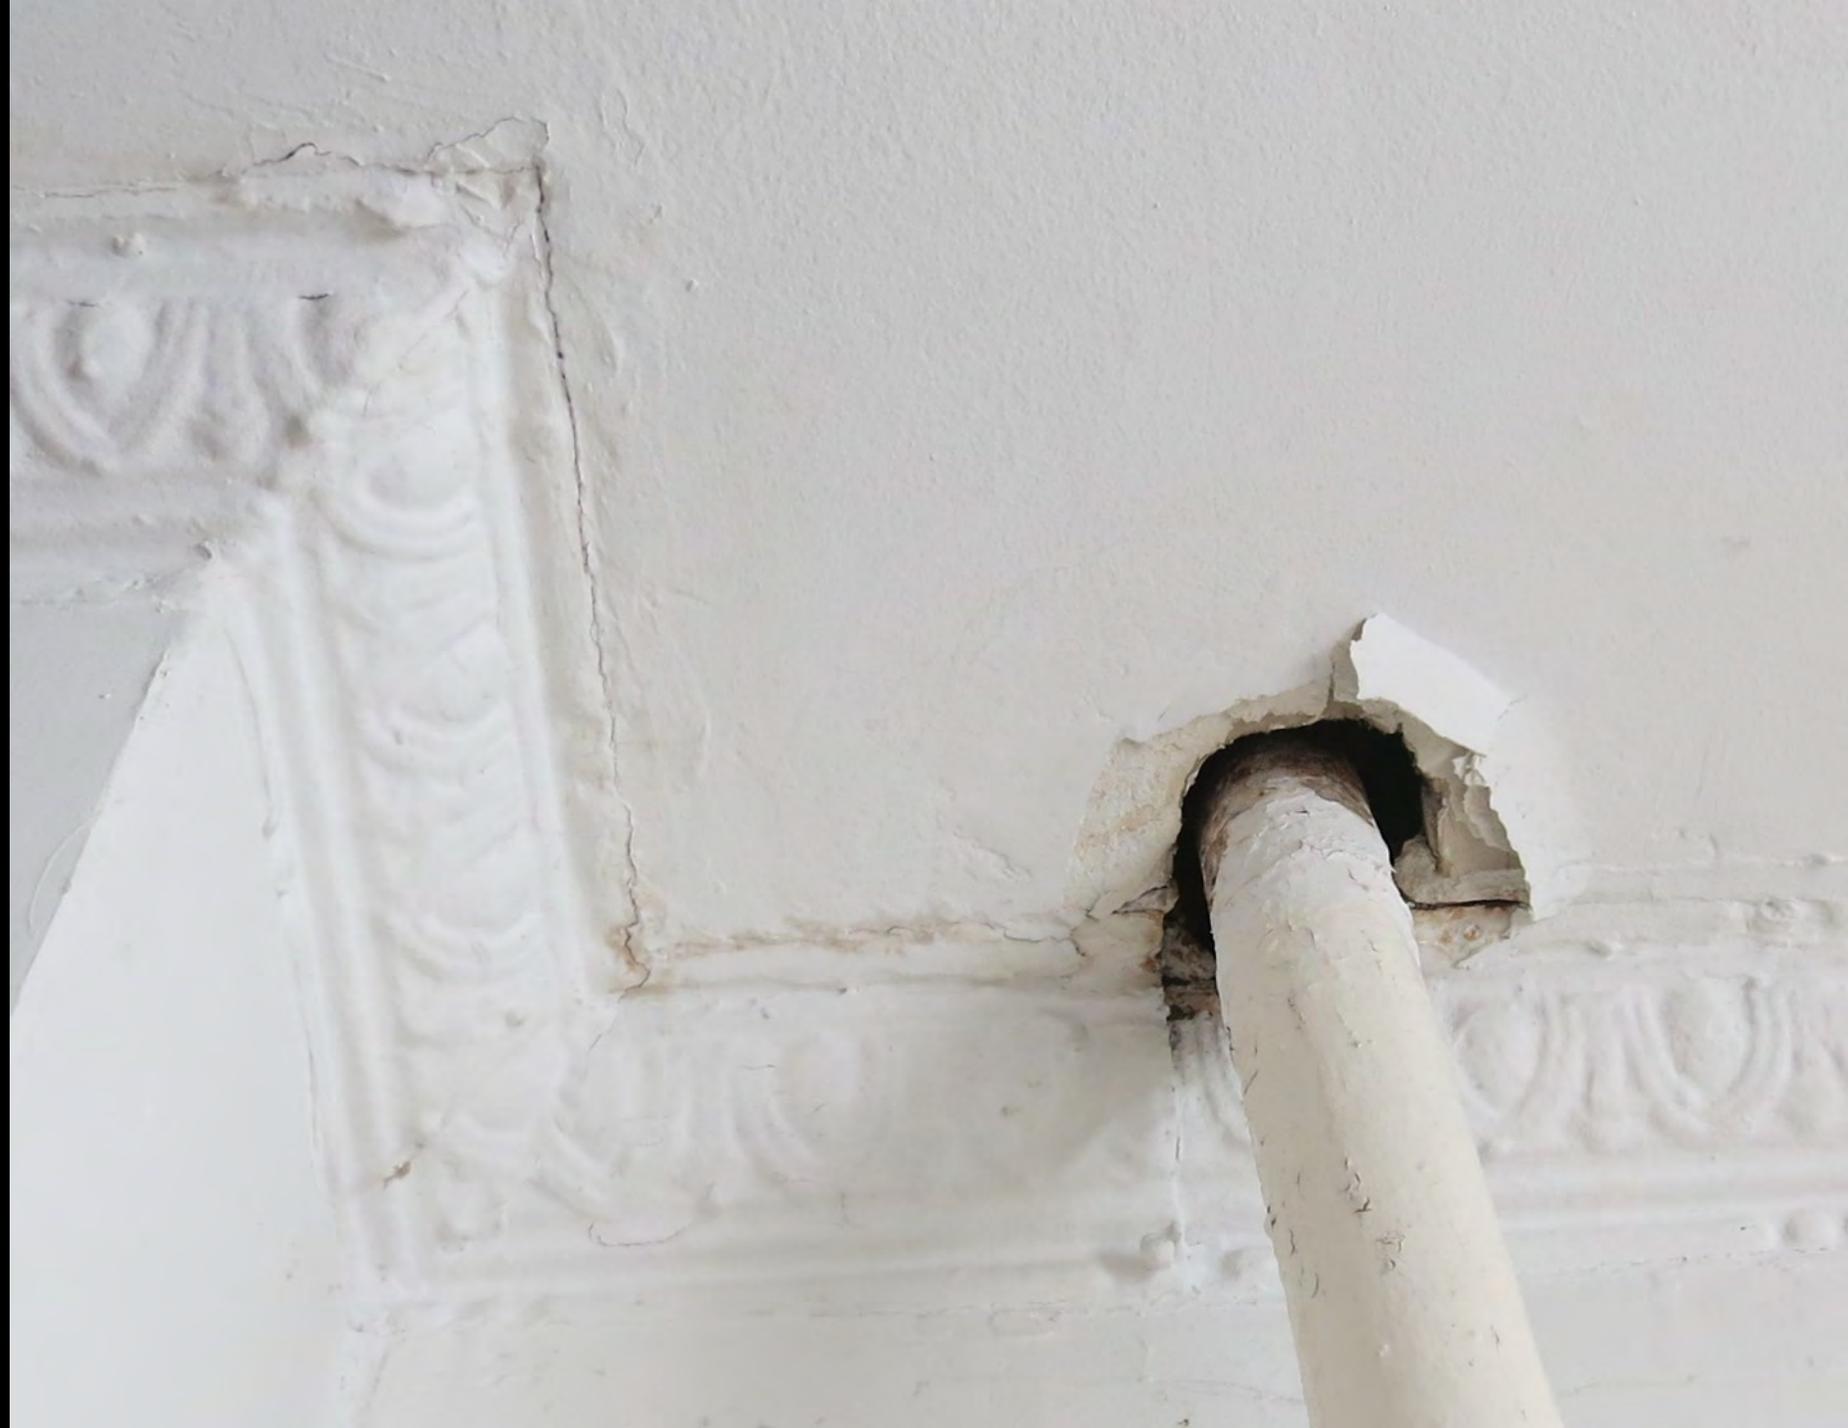
- Biggest leaks in attic and cellar
- Service shafts open to cellar
- Curtain to seal dryer exhaust from cellar
- Steam pipe penetrations in floor and ceiling
- Voids in plaster hidden from view
- Gaps under baseboards
- Gaps at entry doors

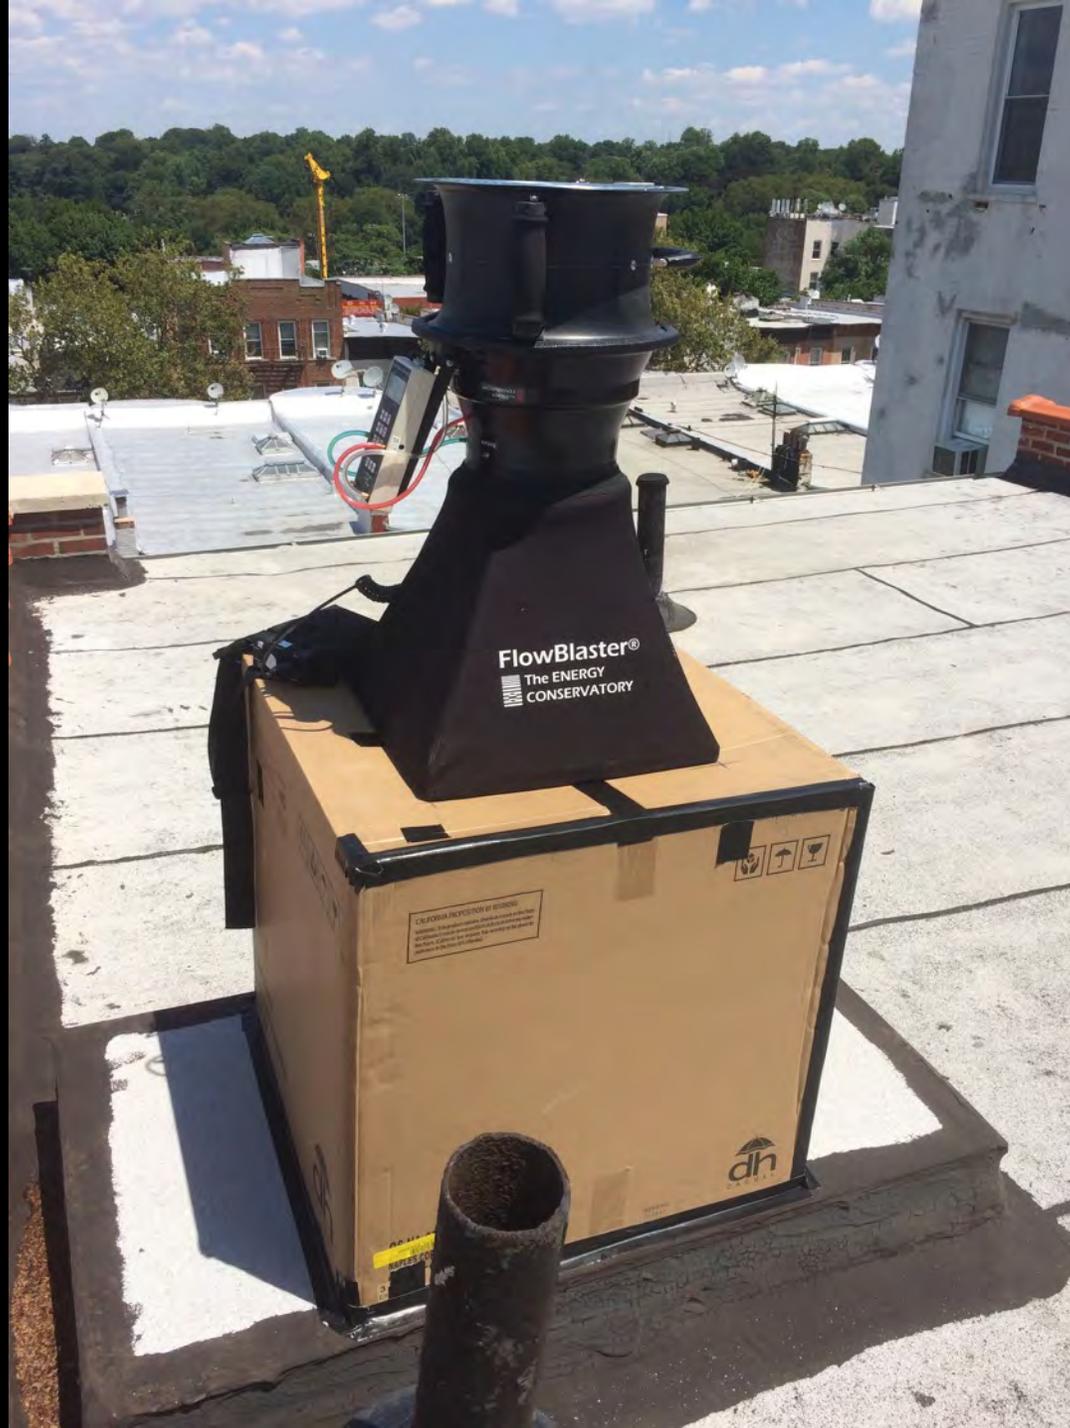
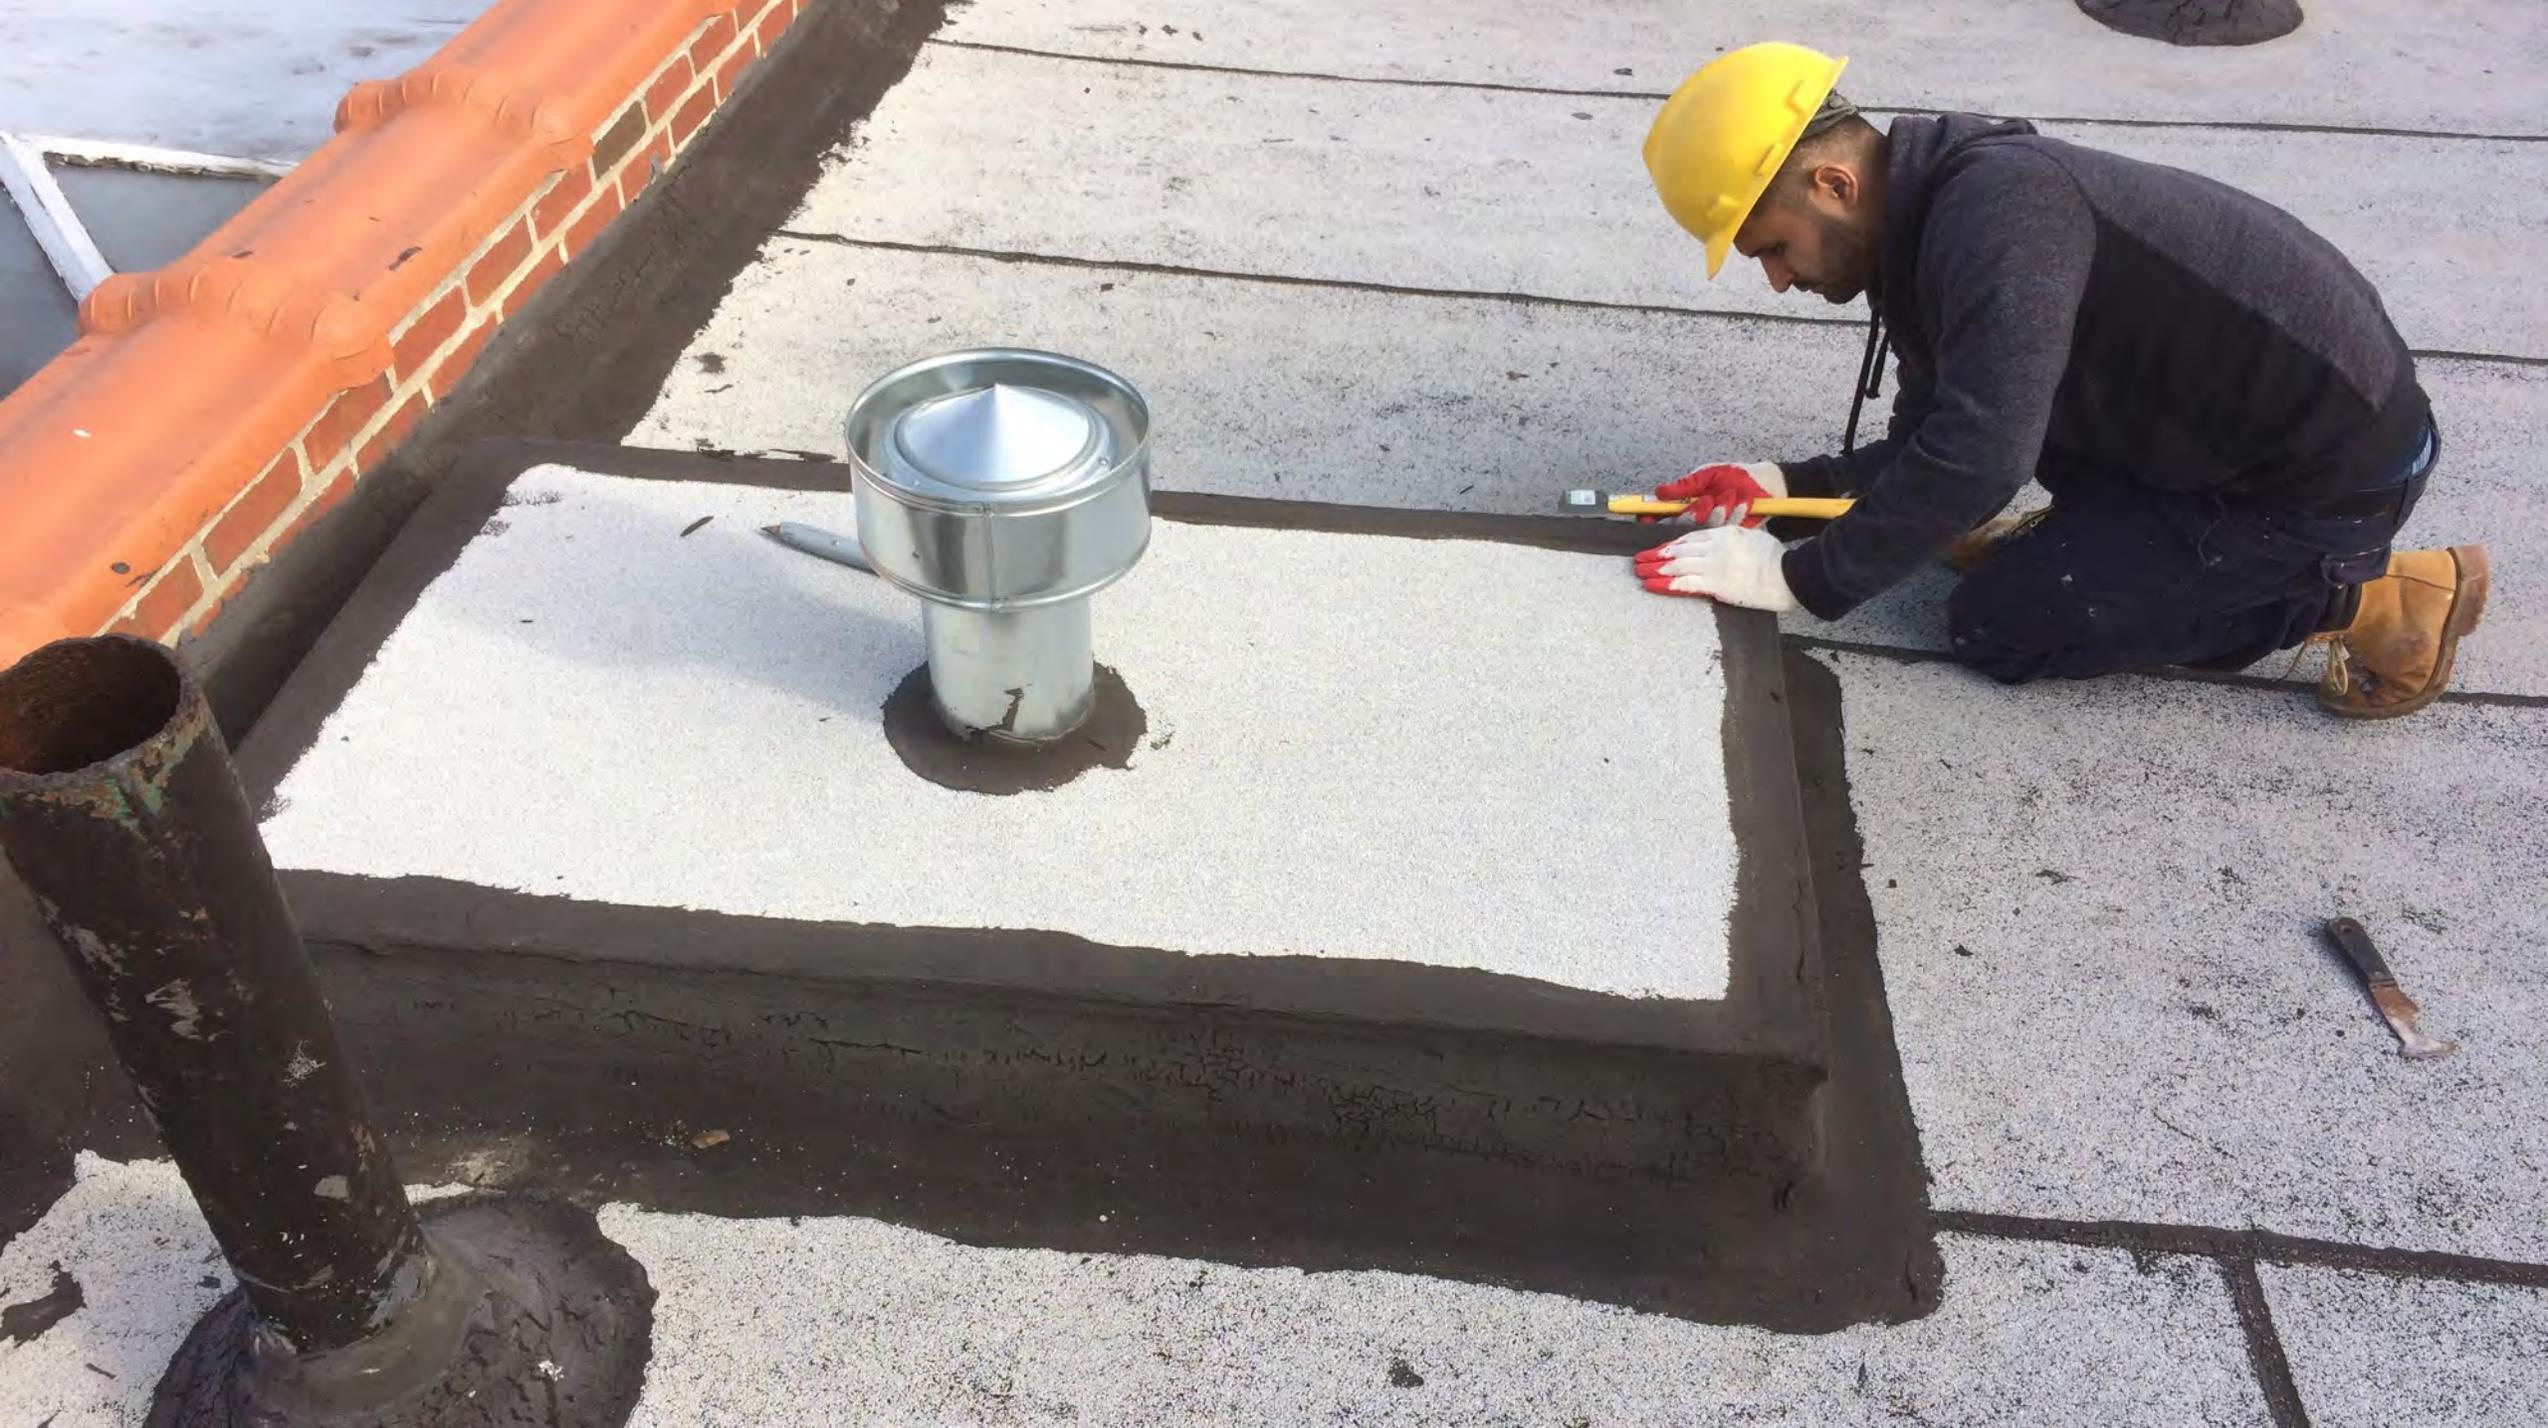
- Termination showed no particular flow with all fans on
- Hypothesized that risers terminate in interstitial space

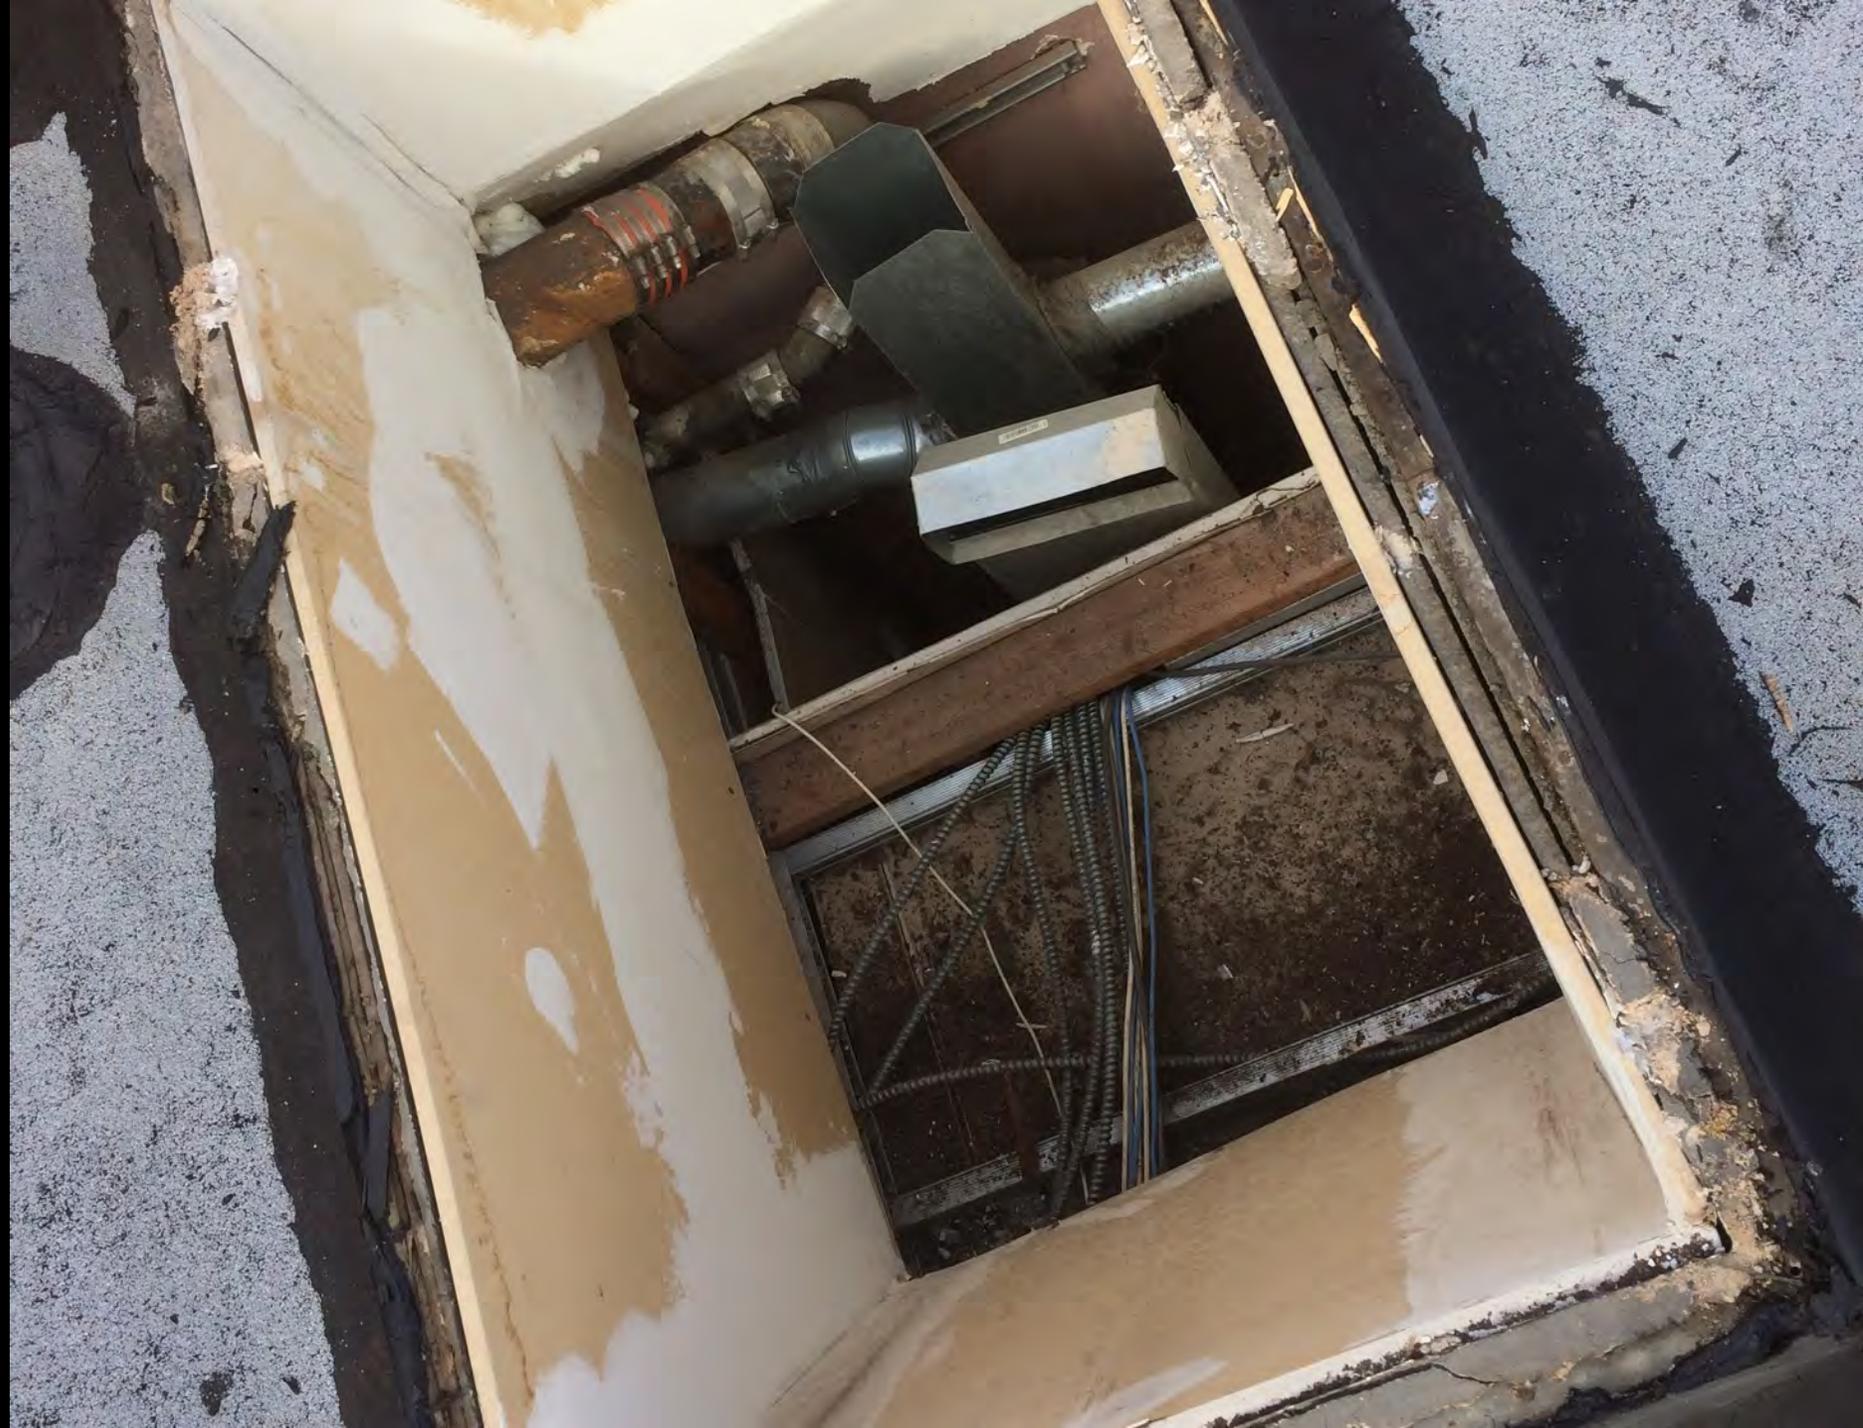
- Termination showed no particular flow with all fans on
- Hypothesized that risers terminate in interstitial space

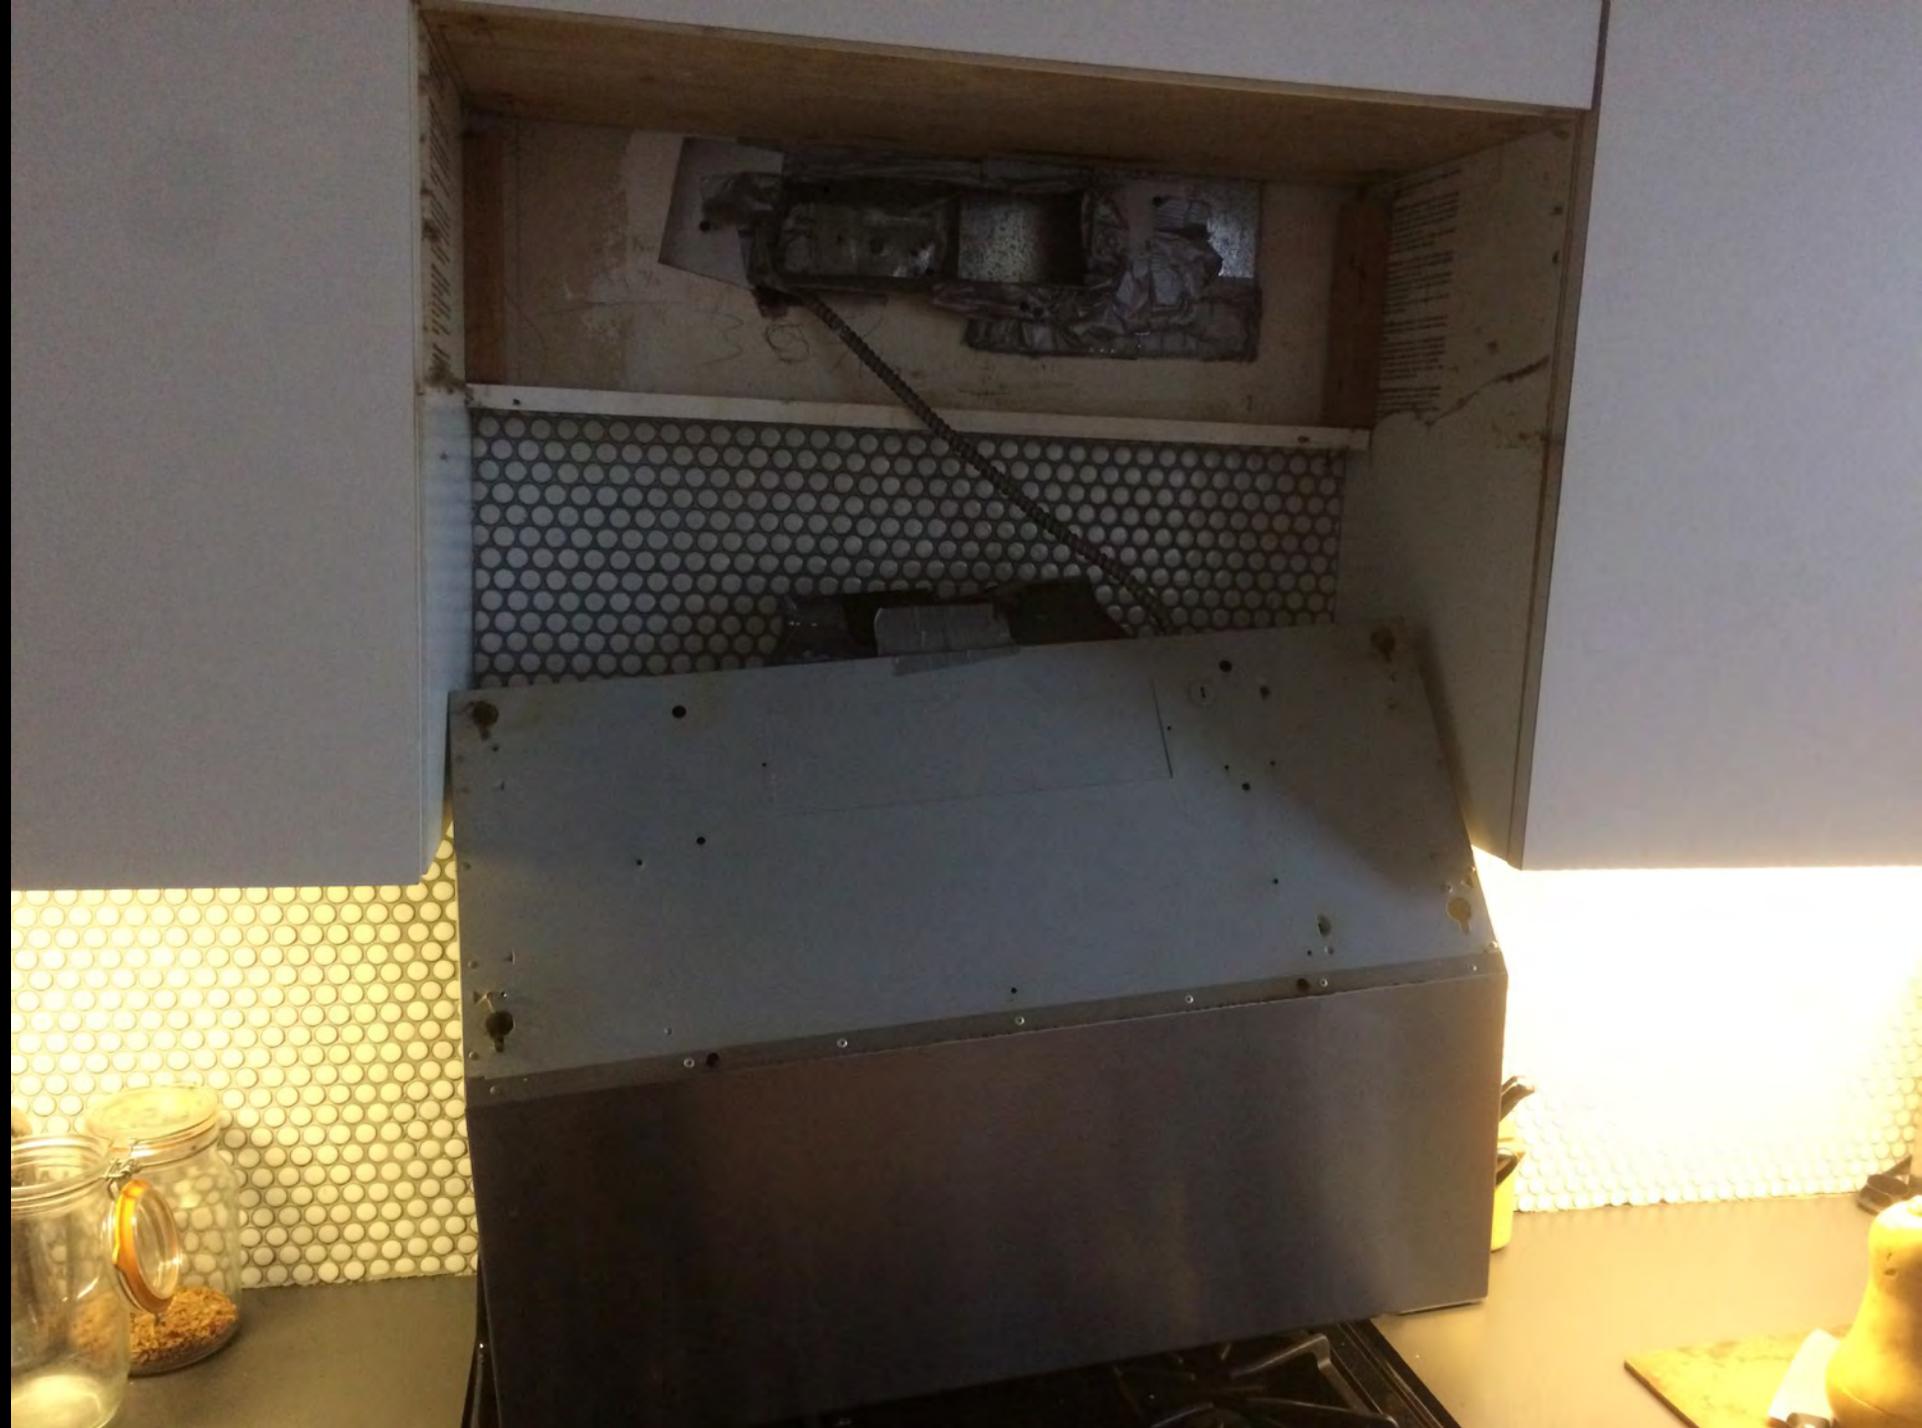
- Termination showed no particular flow with all fans on
- Hypothesized that risers terminate in interstitial space
- Poor kitchen hood to duct connection

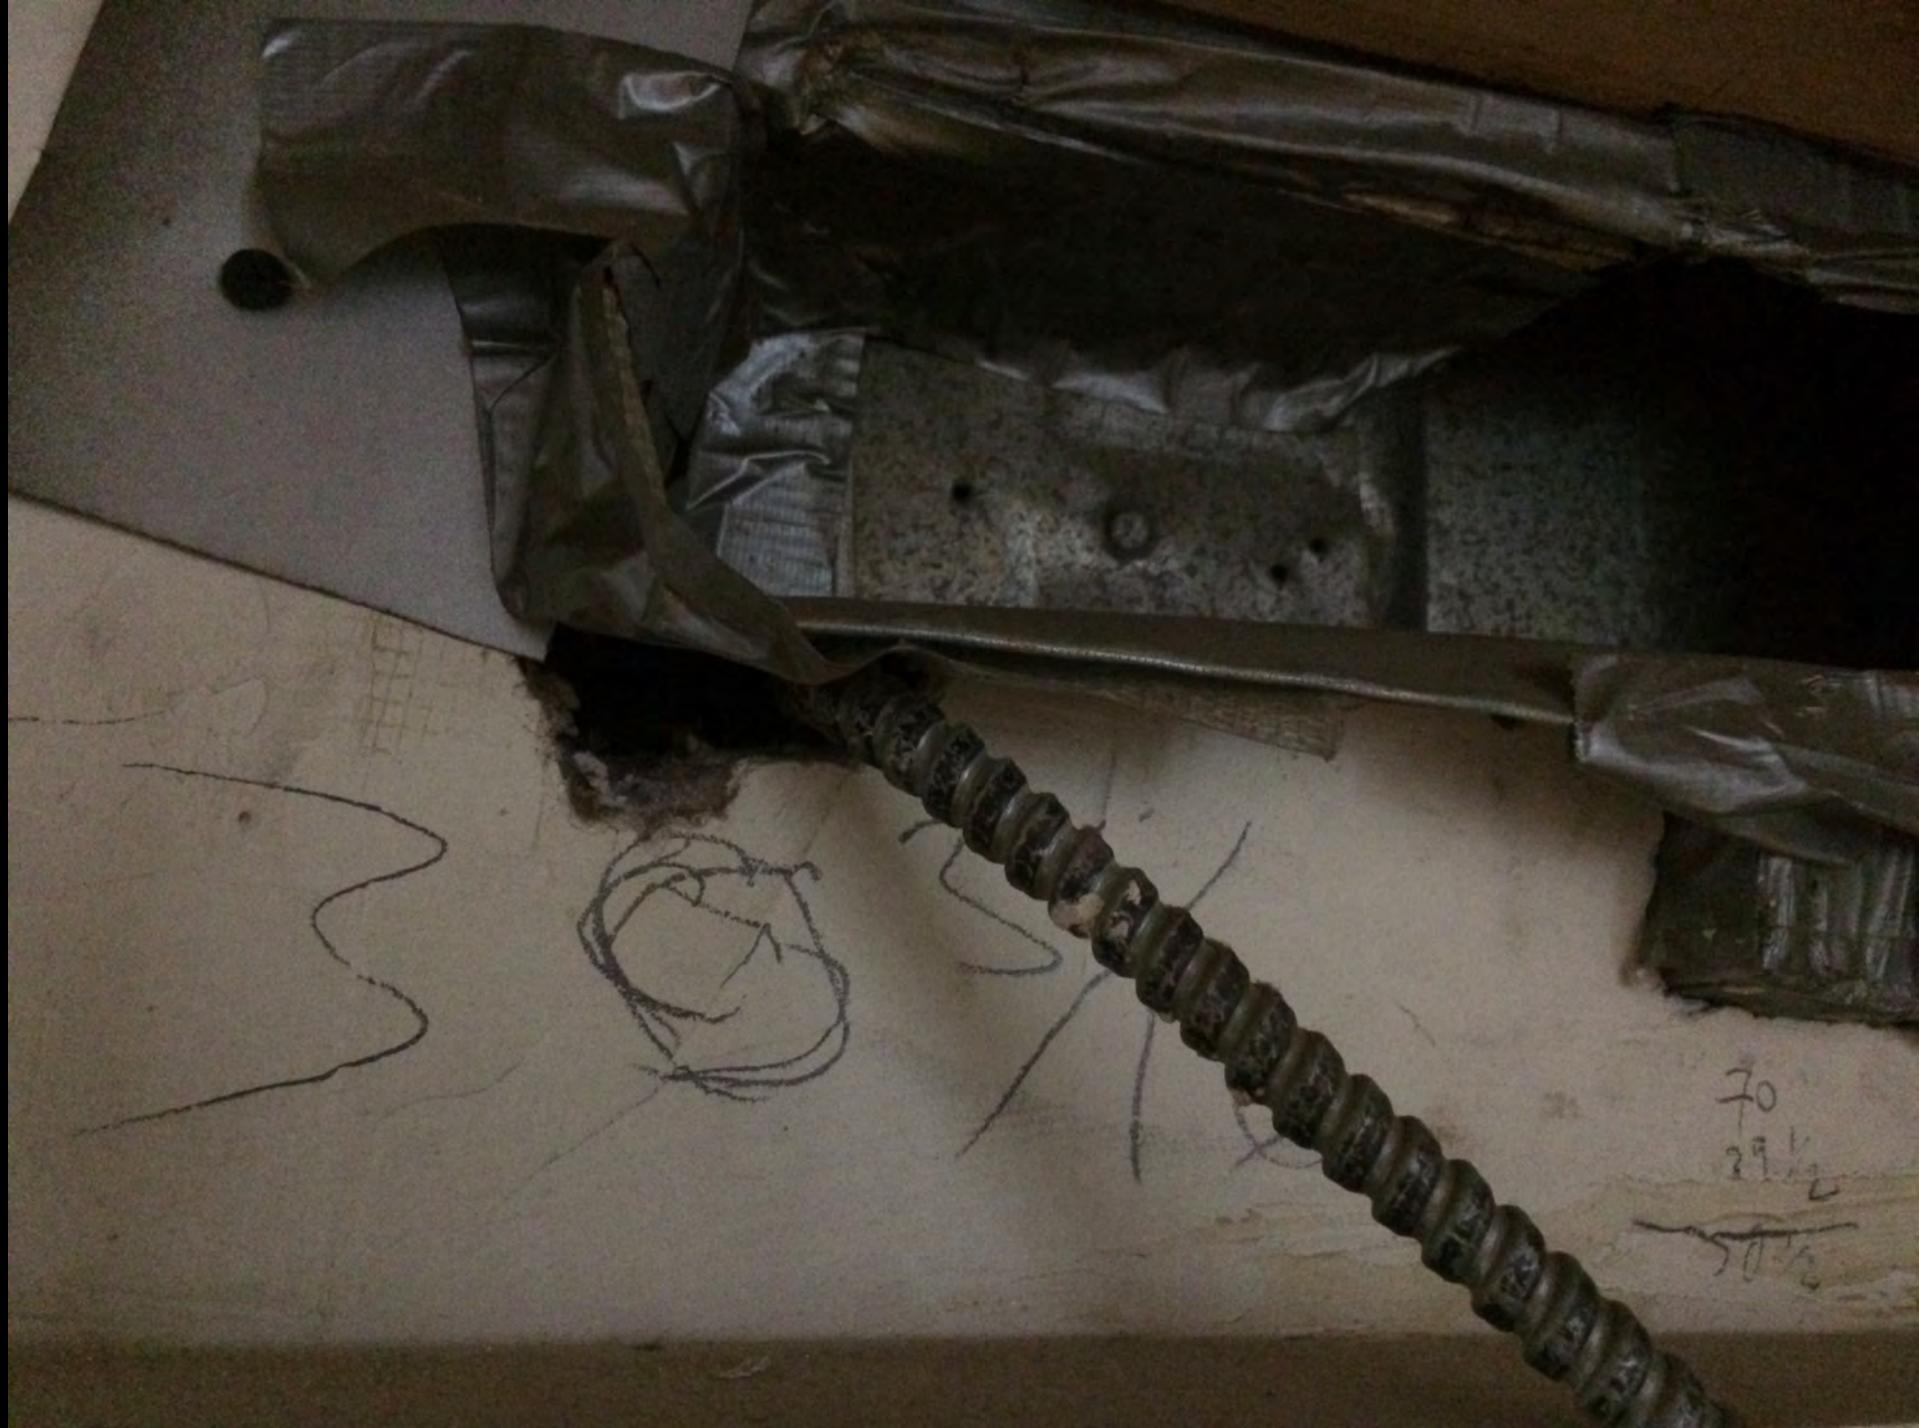
- Termination showed no particular flow with all fans on
- Hypothesized that risers terminate in interstitial space
- Poor kitchen hood to duct connection
- Durability issues with duct tape, many seams not sealed at all

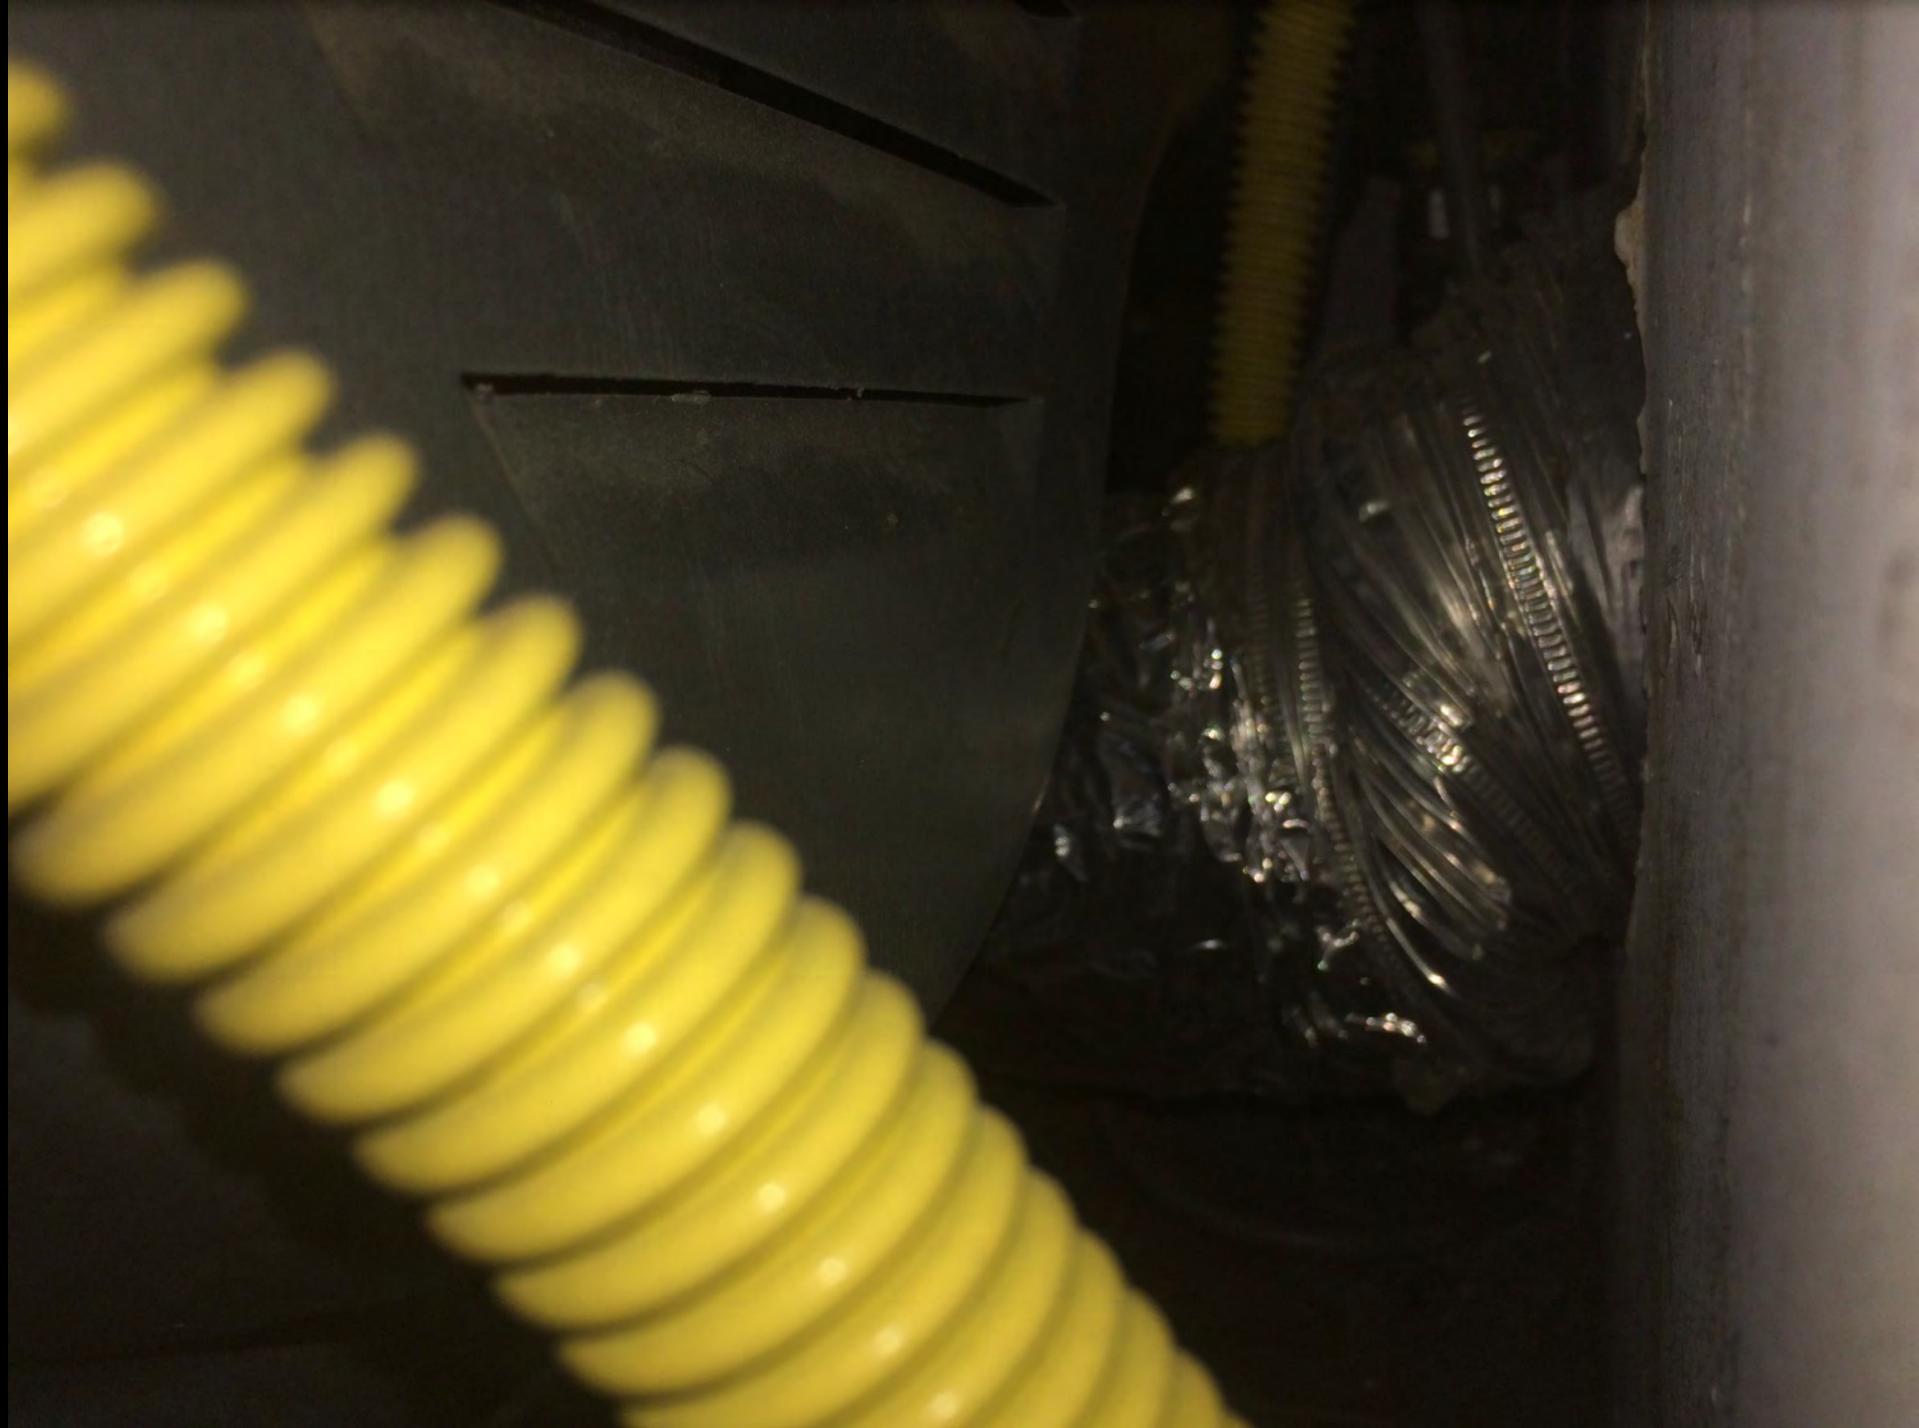
- Crumpled flex

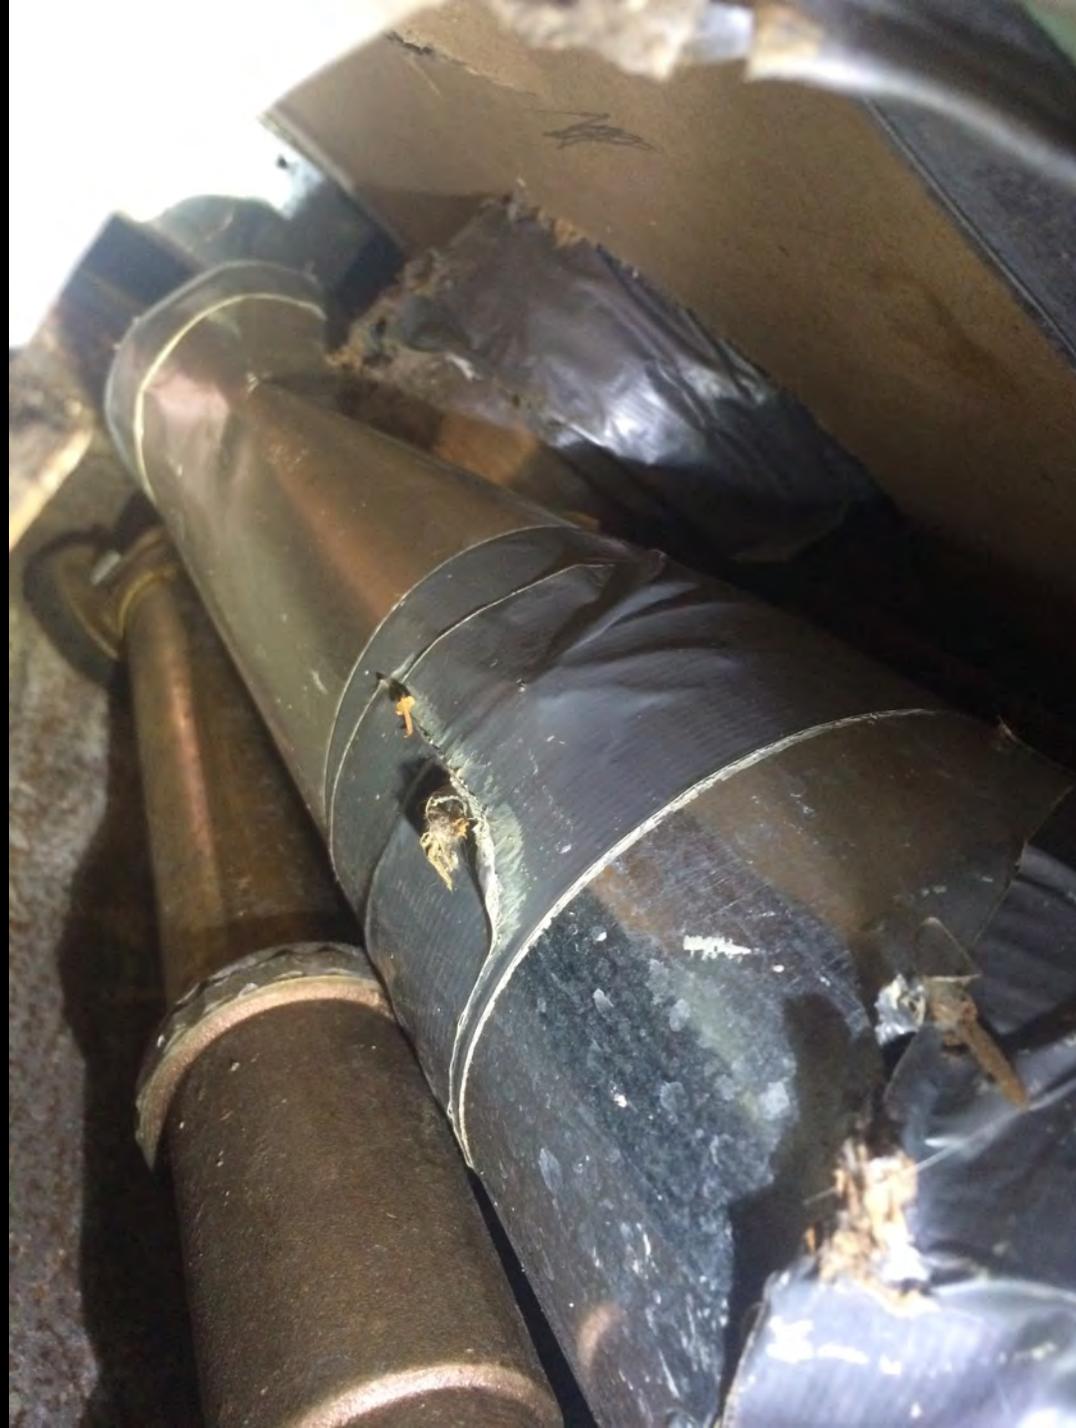
- Crumpled flex
- Pinched bullnose
- 6 or more adjustable elbows, most at 90°
- Duct tape seals, on transverse joints only

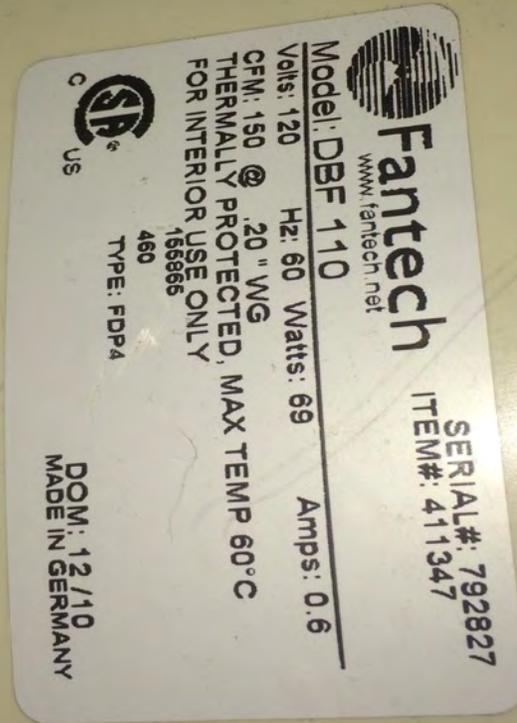
- Crumpled flex
- Pinched bullnose
- 6 or more adjustable elbows, mostly at 90°
- Duct tape seals, on transverse joints only
- Booster fan disconnected

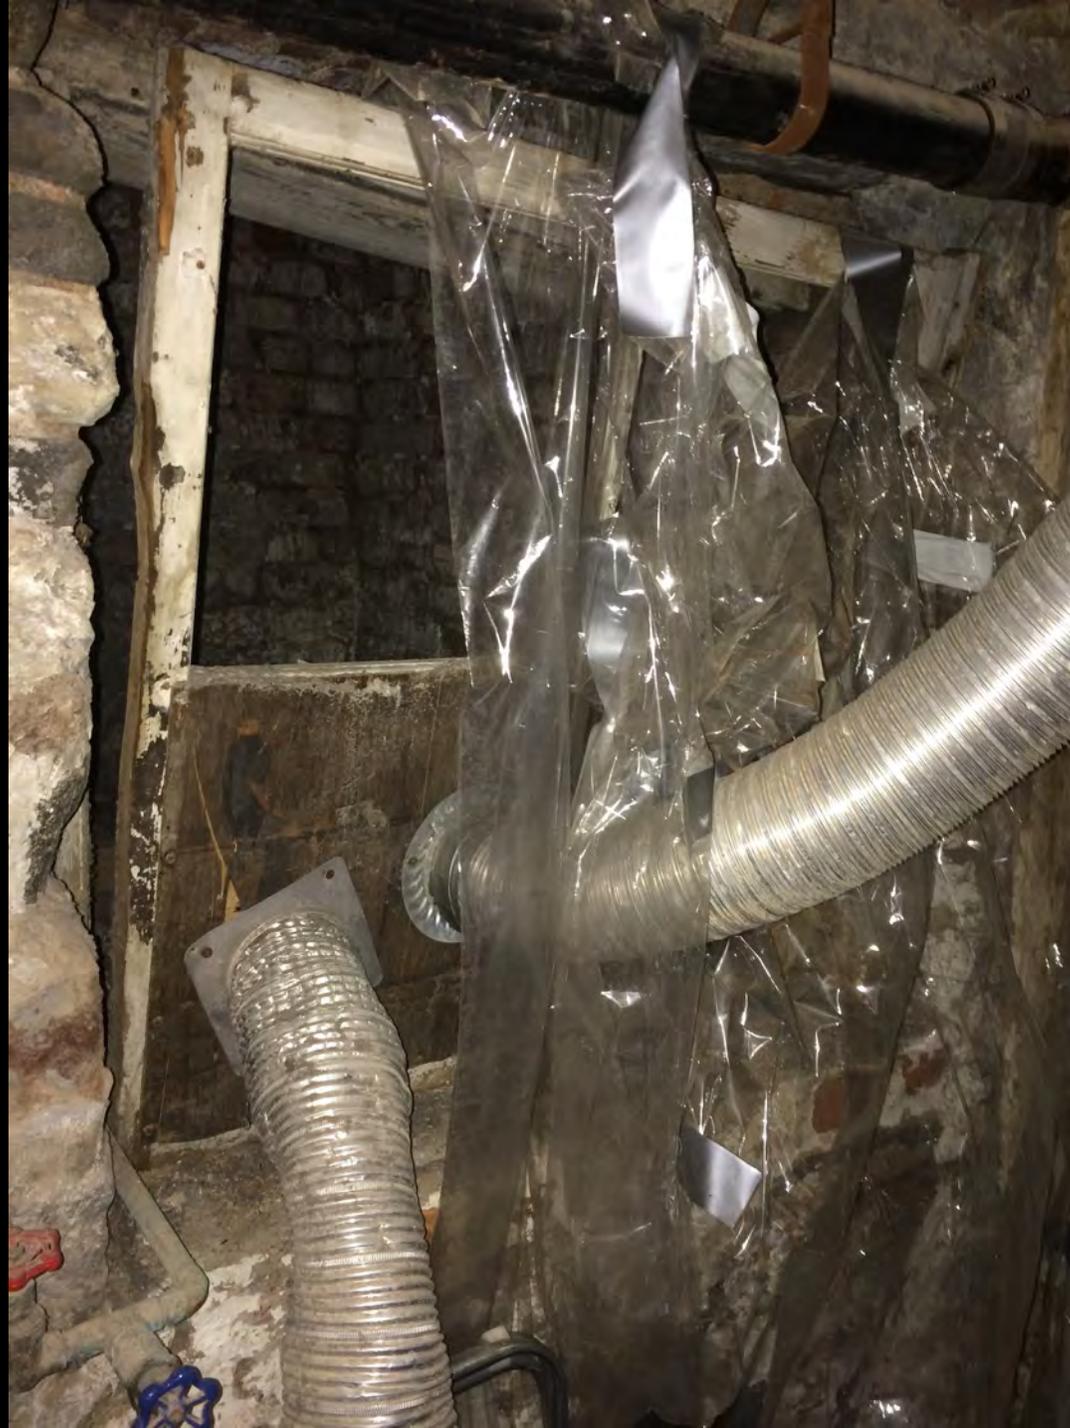
- Crumpled flex
- Pinched bullnose
- 6 or more adjustable elbows, mostly at 90°
- Duct tape seals, on transverse joints only
- Booster fan disconnected
- Exhaust termination not blocked from cellar
