Net Zero Energy Retrofit of a Brooklyn Townhouse

David White
Right Environments

Jason Taylor
Byggmeister

McGowan Southworth
Brooklyn Power

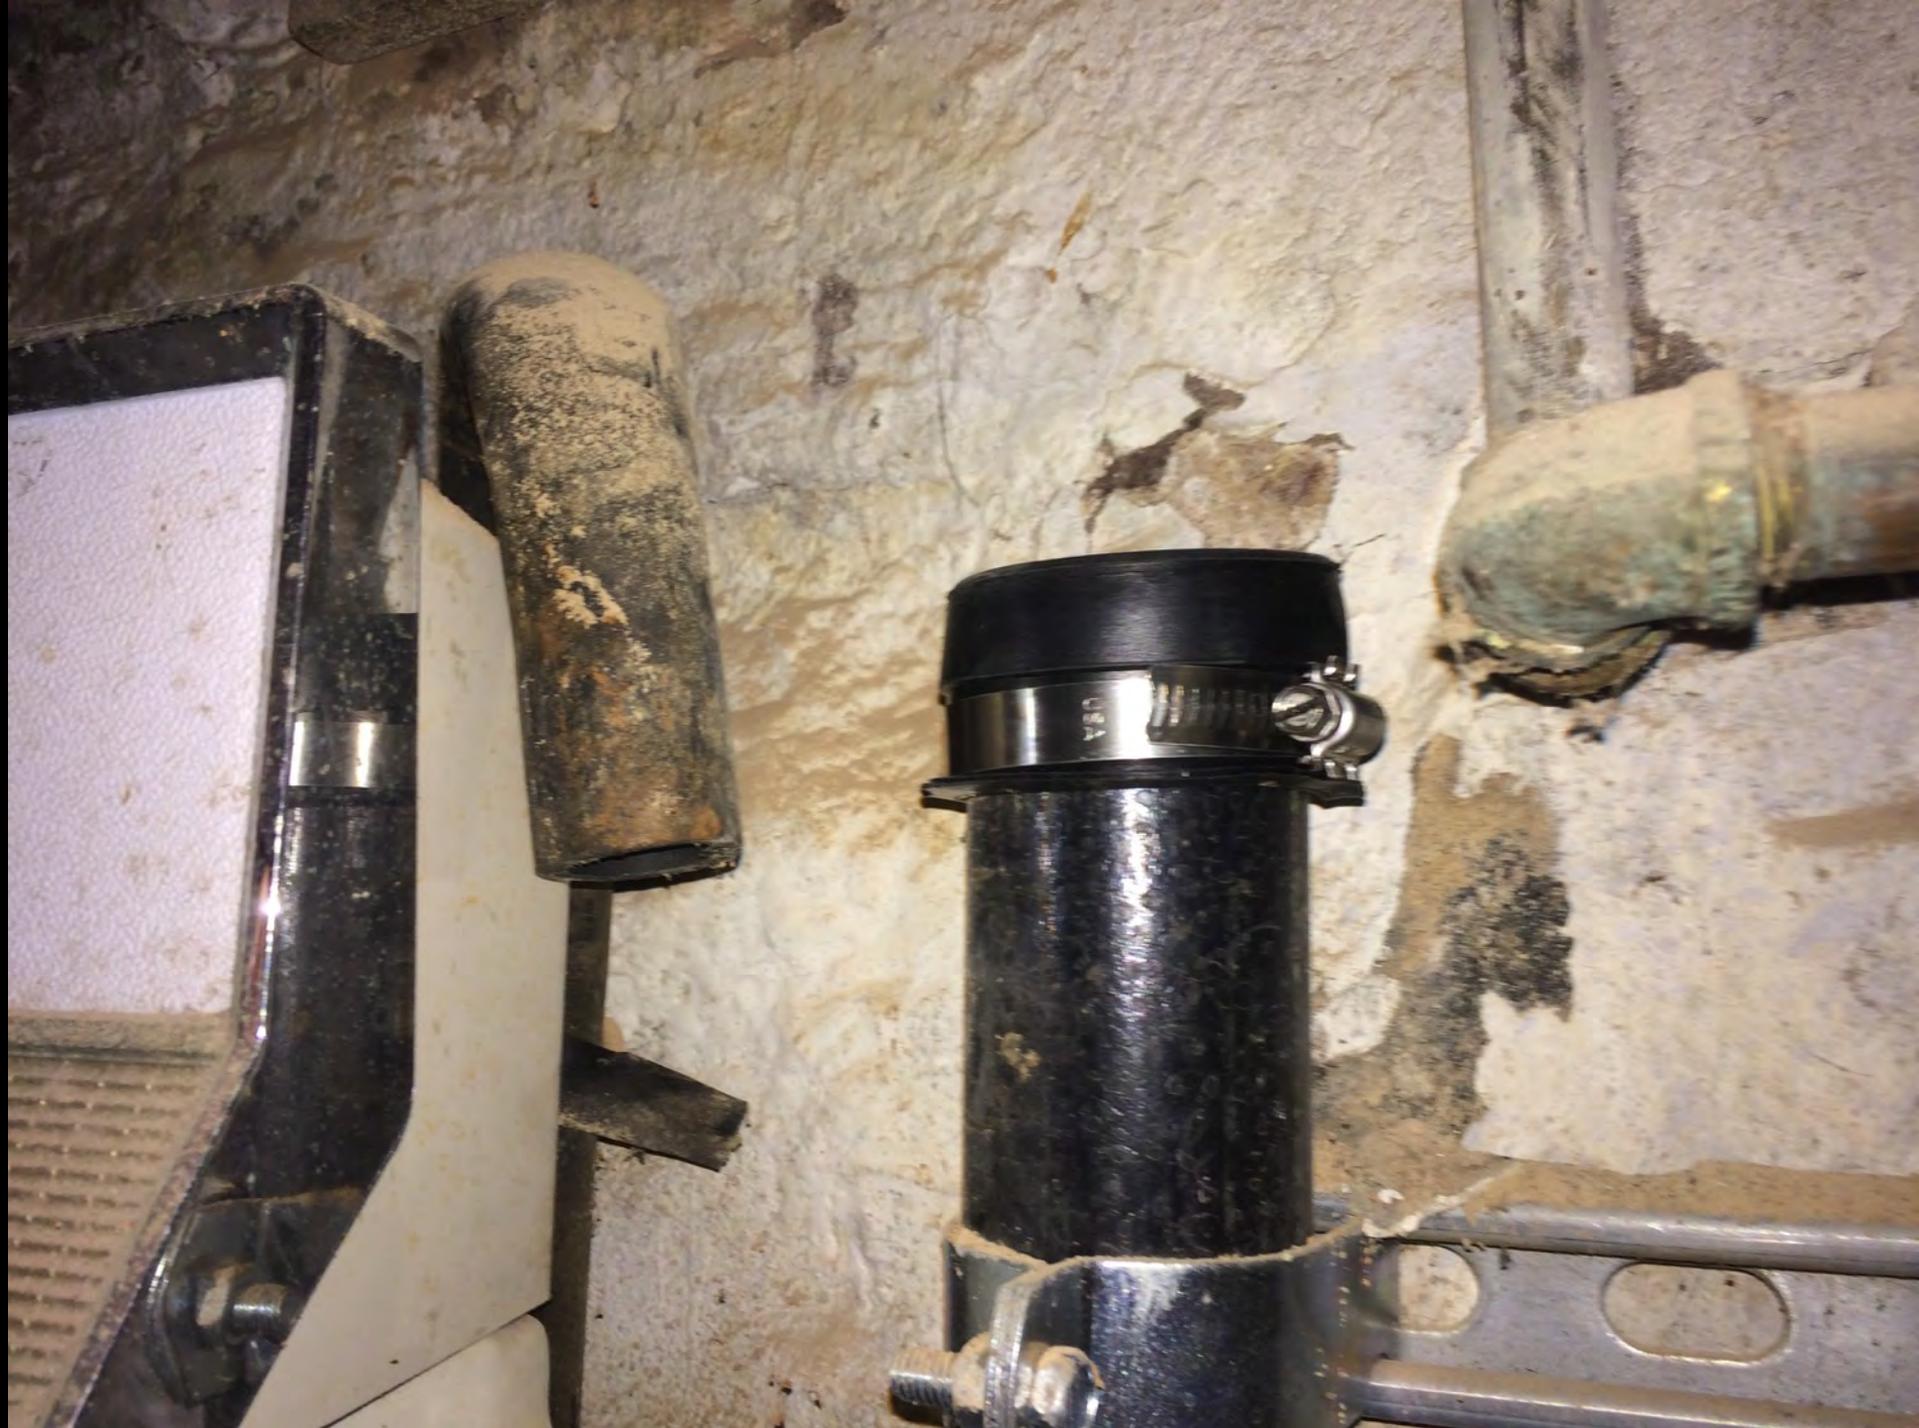
- Out of use washer, dry trap in drain
- Missing cap on house trap
