#### Overview

- Focus: Verification of Insulation and Air Barrier Continuity
- Issues that dictate QA/QC program
- Case Studies
  - Cornell
  - Beach Green North
  - -3365 Third Ave

## CORNELL ROOSEVELT ISLAND, NY

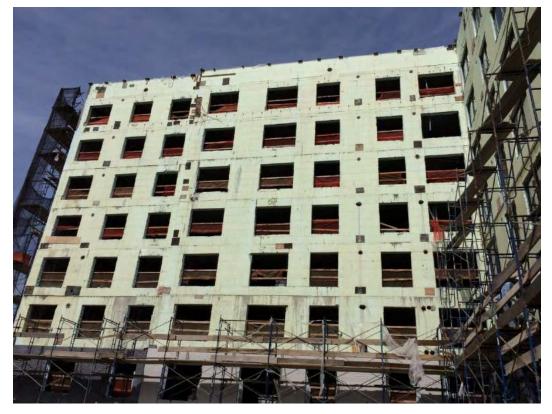
### Wall Insulation Inspections

ICF doesn't require as many inspections for insulation

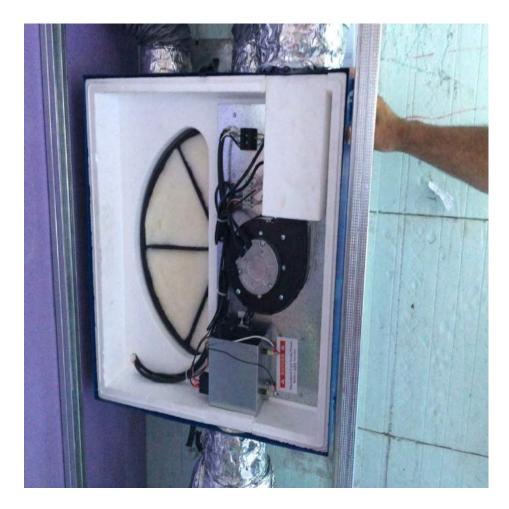
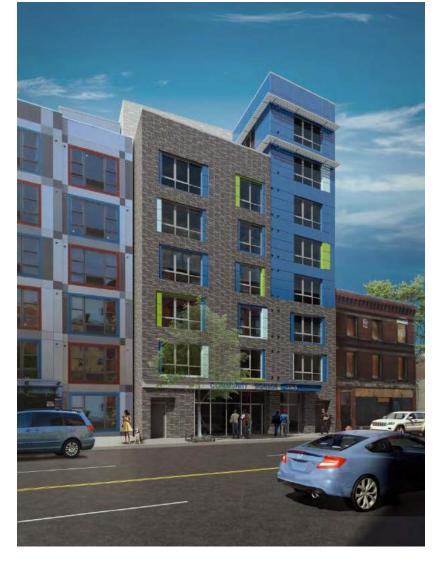
### Individual ERV & Blower Door

- Need to seal off ERV for final test.
- Can't seal off vents from outside
- Will leave ducts to unit disconnected at first, then connect after testing.
